Hybrid 8j352 Traveler

June 9, 2000

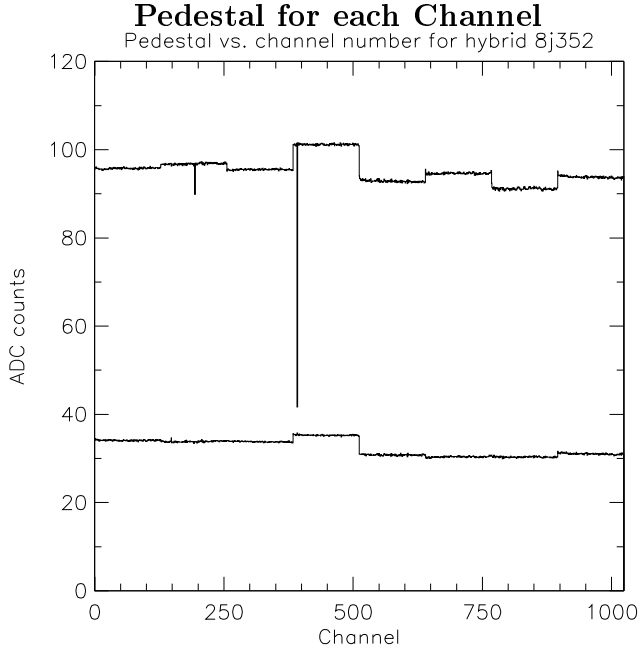
Pedestal for each Channel

The following plot shows the pedestals vs. channel number with and without charge injection:

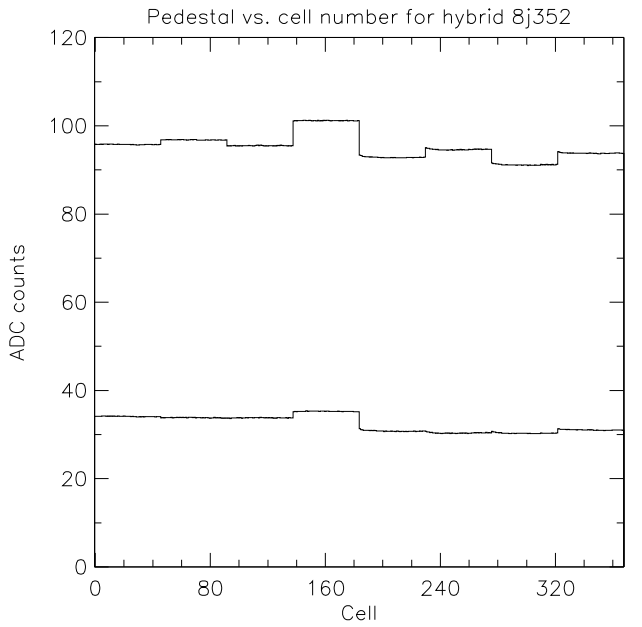
Pedestal vs. Pipeline Cell ID

The following plot shows the average pedestal vs. pipeline cell ID with and without charge injection. The x-axis is cell ID offset by 46 for each chip. Thus cell ID 5 for chip 1 is at x=5, chip 2 at x=51, chip 3 at x=97, etc.

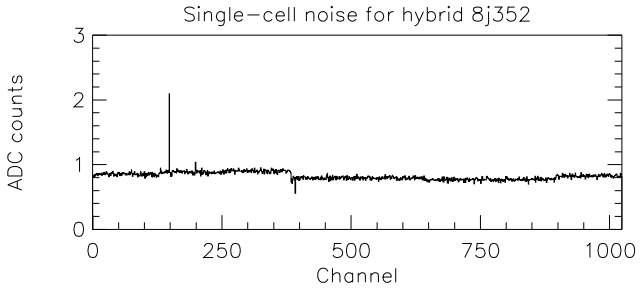
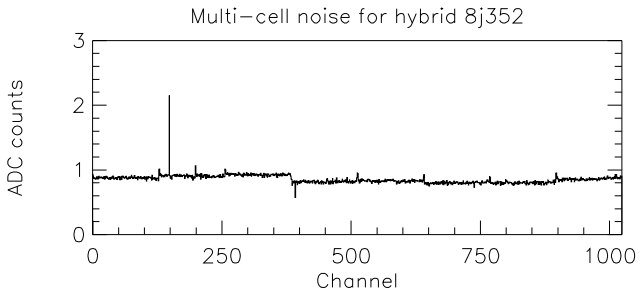
RMS Noise

The following plots show the single-cell and multi-cell RMS noise:

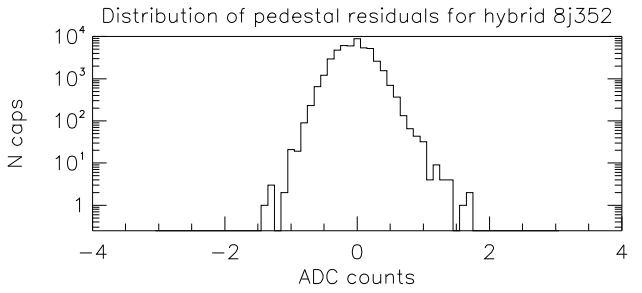
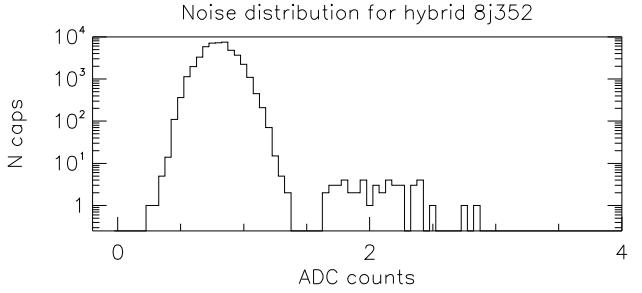
Distribution of Pedestals and Noise

The following are histograms of the pedestal of each pipeline capacitor relative to the chip average (top); and the RMS noise of each capacitor (bottom):

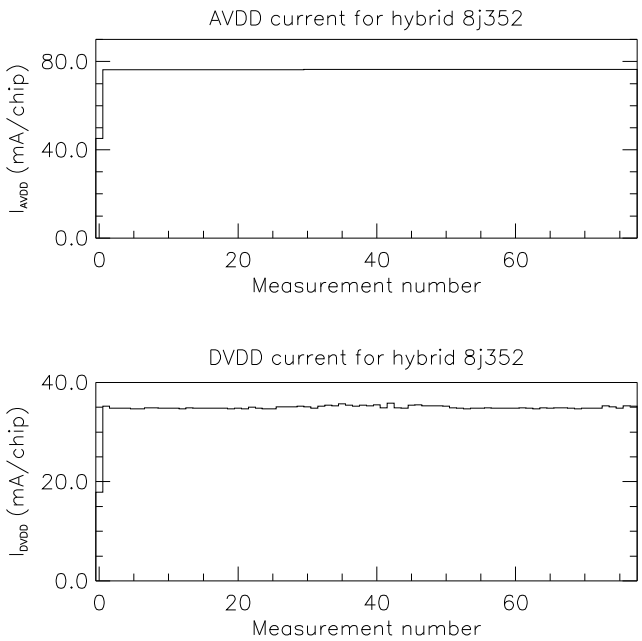
Supply Currents During Burn-in

The following plots show the supply currents per chip as a function of measurment number. Currents are measured approximately every 10 minutes:
