Hybrid 8j353 Traveler

June 9, 2000

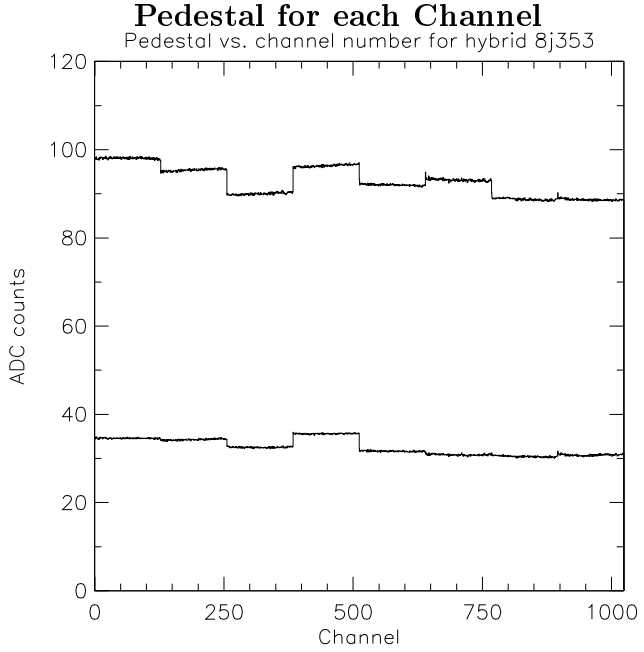
Pedestal for each Channel

The following plot shows the pedestals vs. channel number with and without charge injection:

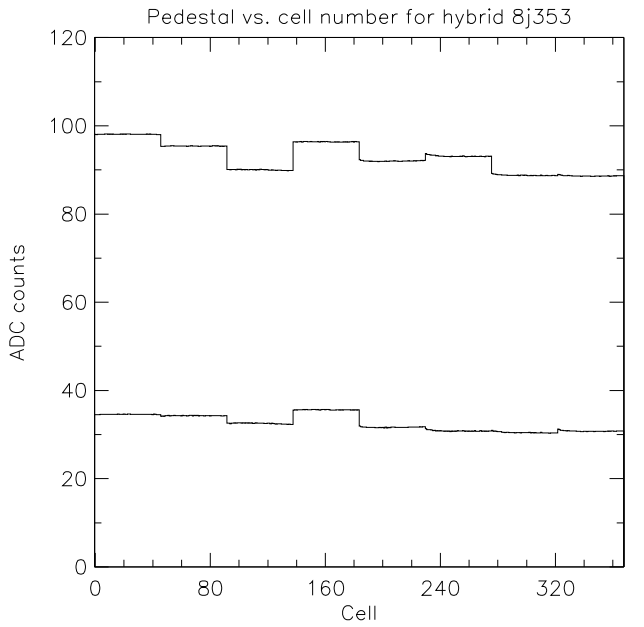
Pedestal vs. Pipeline Cell ID

The following plot shows the average pedestal vs. pipeline cell ID with and without charge injection. The x-axis is cell ID offset by 46 for each chip. Thus cell ID 5 for chip 1 is at x=5, chip 2 at x=51, chip 3 at x=97, etc.

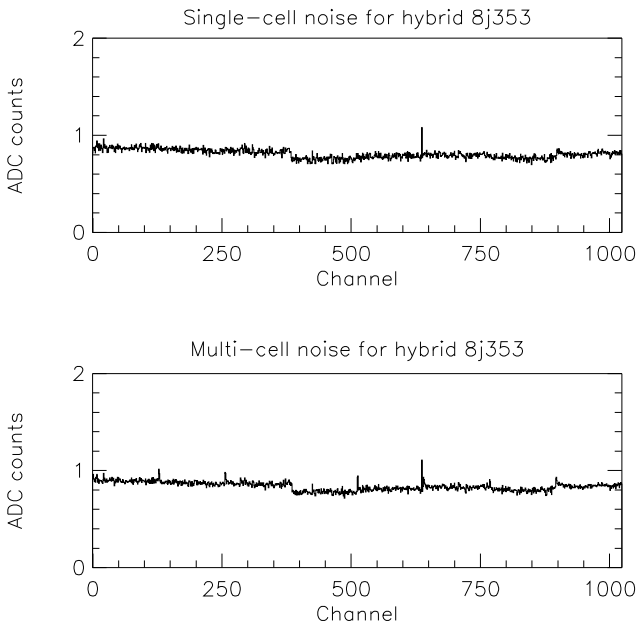
RMS Noise

The following plots show the single-cell and multi-cell RMS noise:

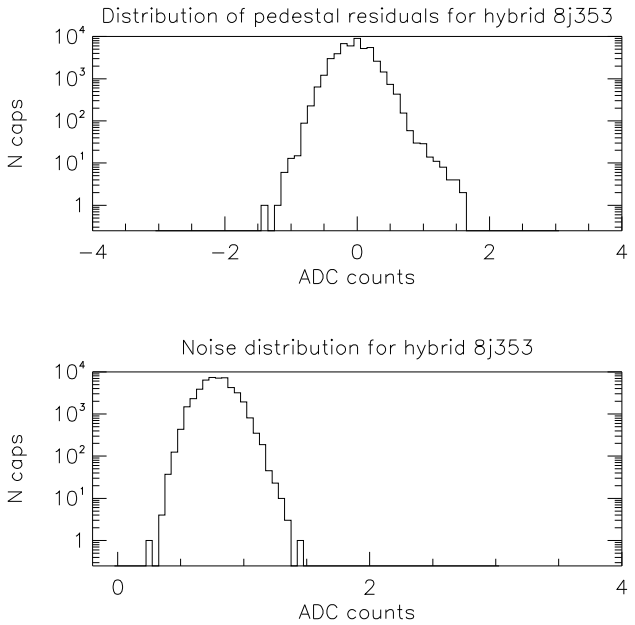
Distribution of Pedestals and Noise

The following are histograms of the pedestal of each pipeline capacitor relative to the chip average (top); and the RMS noise of each capacitor (bottom):

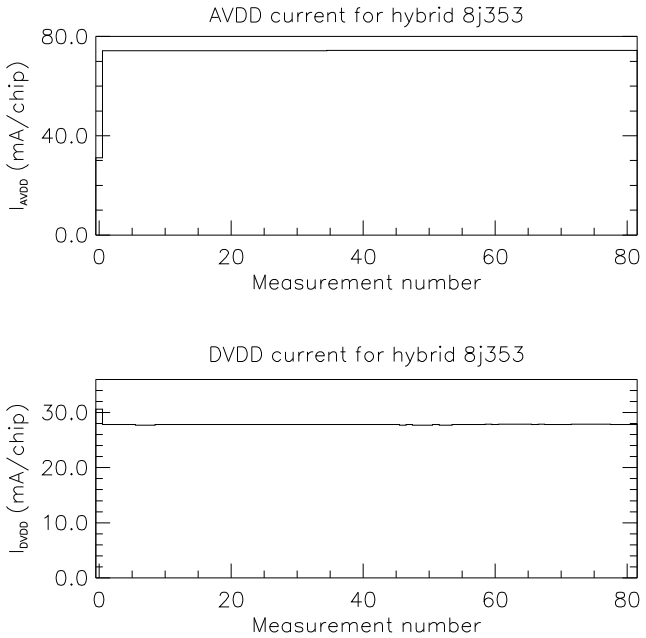
Supply Currents During Burn-in

The following plots show the supply currents per chip as a function of measurment number. Currents are measured approximately every 10 minutes:
