Hybrid 8j355 Traveler

June 26, 2000

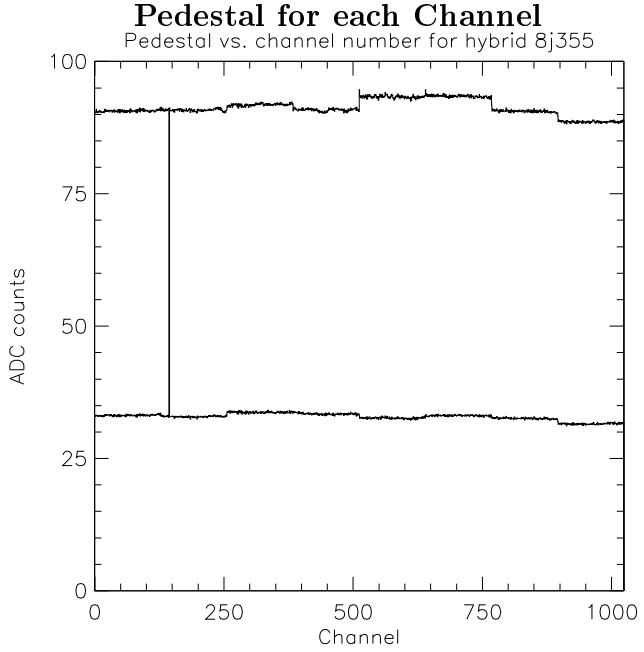
Pedestal for each Channel

The following plot shows the pedestals vs. channel number with and without charge injection:

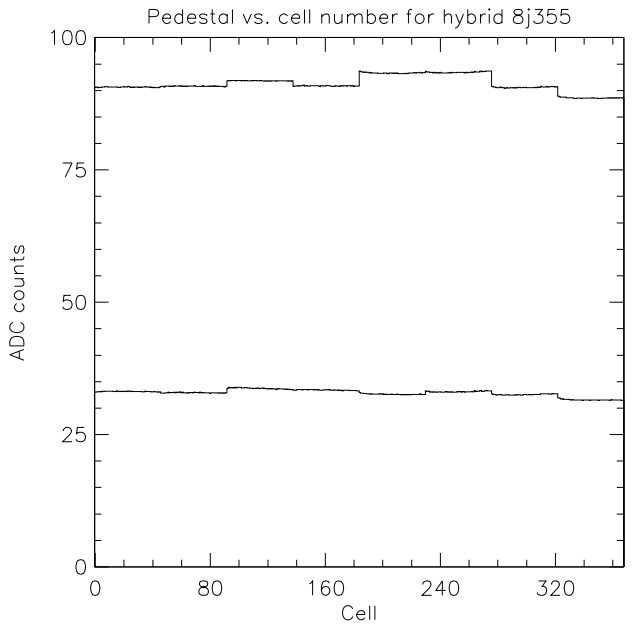
Pedestal vs. Pipeline Cell ID

The following plot shows the average pedestal vs. pipeline cell ID with and without charge injection. The x-axis is cell ID offset by 46 for each chip. Thus cell ID 5 for chip 1 is at x=5, chip 2 at x=51, chip 3 at x=97, etc.

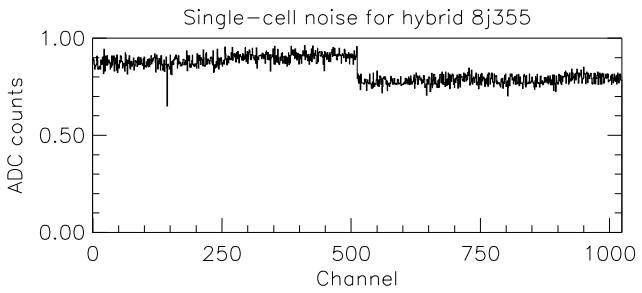
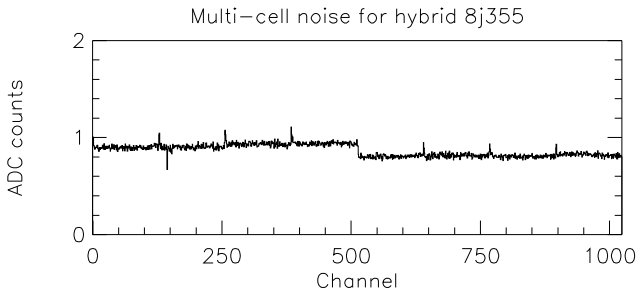
RMS Noise

The following plots show the single-cell and multi-cell RMS noise:

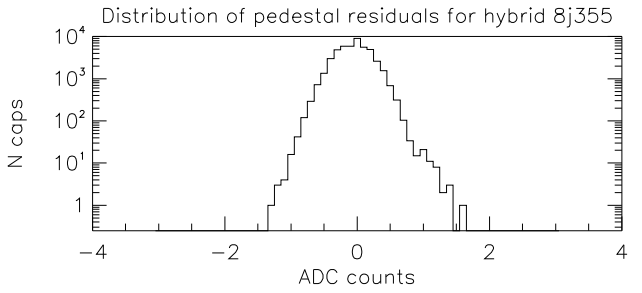
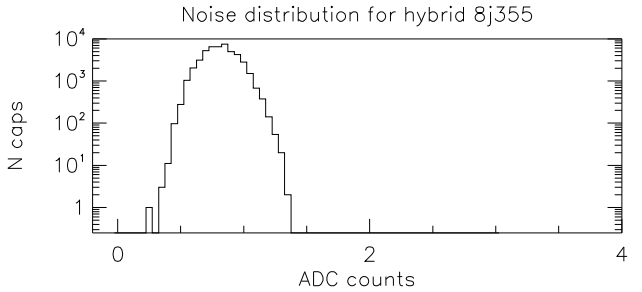
Distribution of Pedestals and Noise

The following are histograms of the pedestal of each pipeline capacitor relative to the chip average (top); and the RMS noise of each capacitor (bottom):

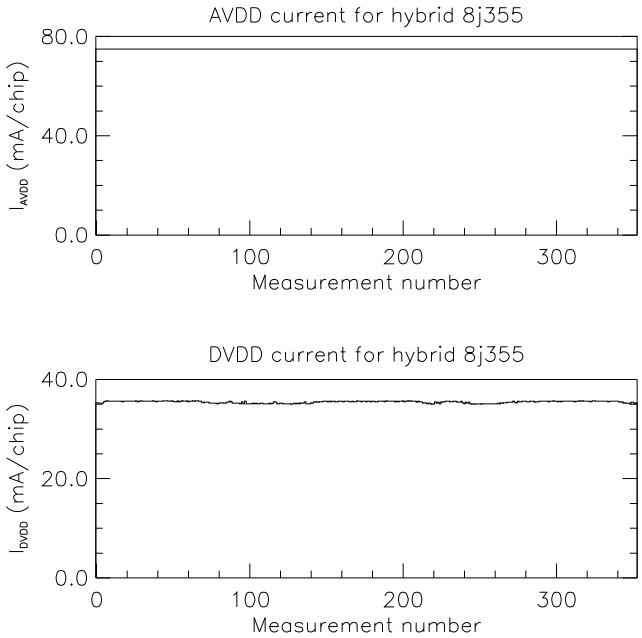
Supply Currents During Burn-in

The following plots show the supply currents per chip as a function of measurment number. Currents are measured approximately every 10 minutes:
