Hybrid 8j359 Traveler

May 31, 2000

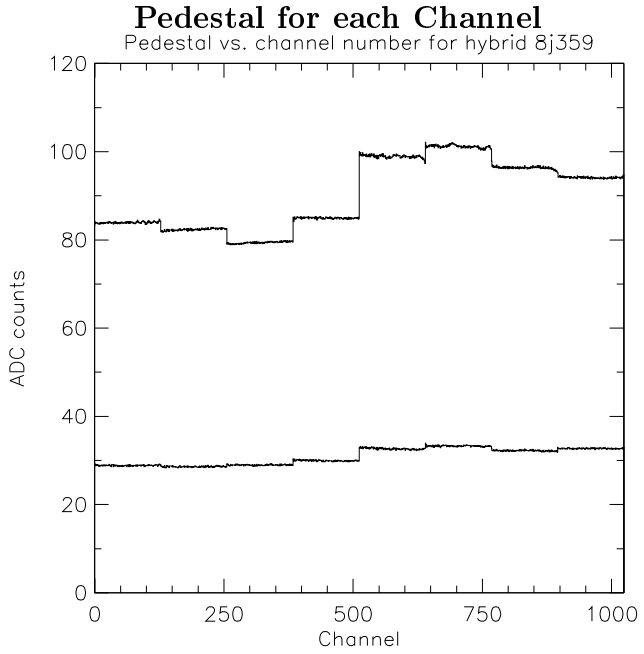
The following plot shows the pedestals vs. channel number with and without charge injection:

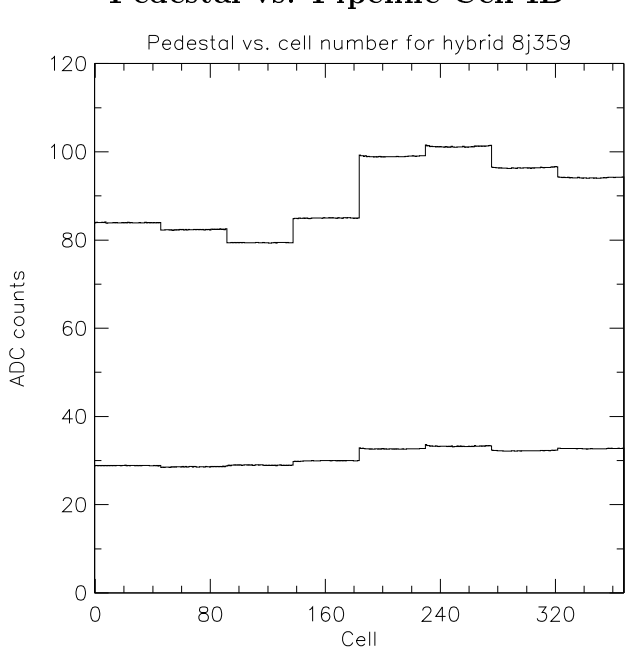
The following plot shows the average pedestal vs. pipeline cell ID with and without charge injection. The x-axis is cell ID offset by 46 for each chip. Thus cell ID 5 for chip 1 is at x=5, chip 2 at x=51, chip 3 at x=97, etc.

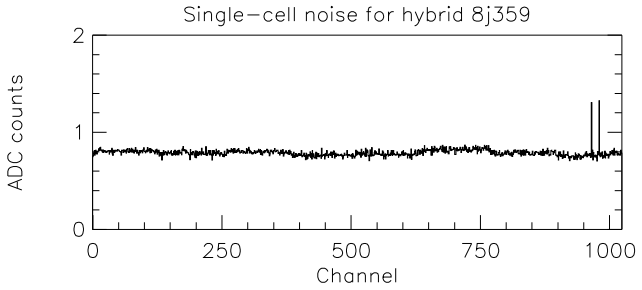
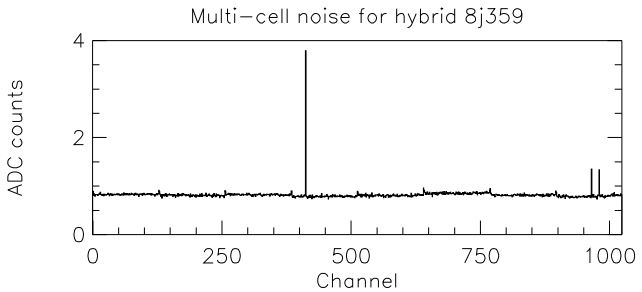
RMS Noise

The following plots show the single-cell and multi-cell RMS noise:

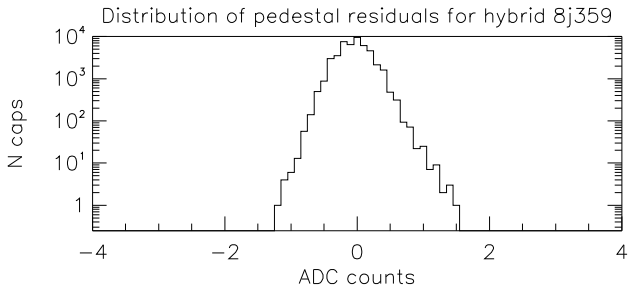
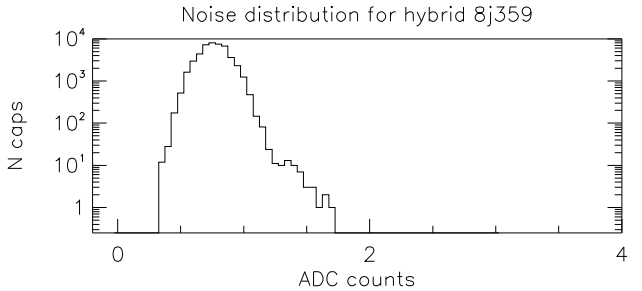
Distribution of Pedestals and Noise

The following are histograms of the pedestal of each pipeline capacitor relative to the chip average (top); and the RMS noise of each capacitor (bottom):

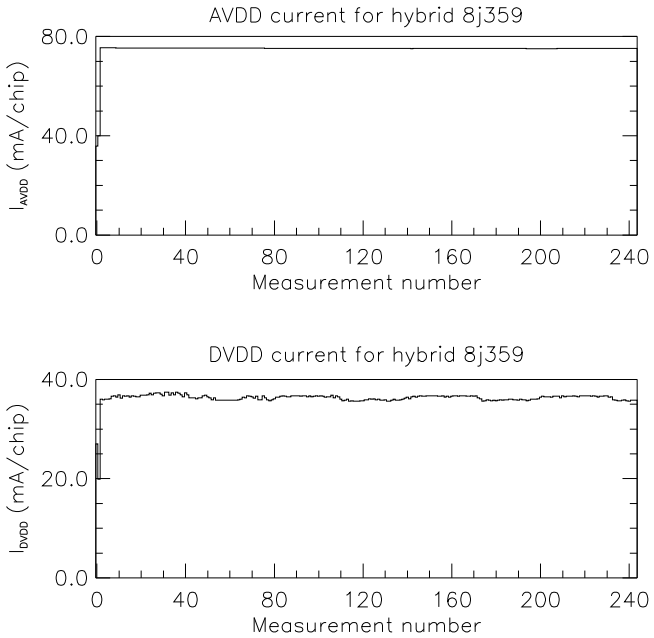
Supply Currents During Burn-in

The following plots show the supply currents per chip as a function of measurment number. Currents are measured approximately every 10 minutes:
