Hybrid 8j365 Traveler

May 26, 2000

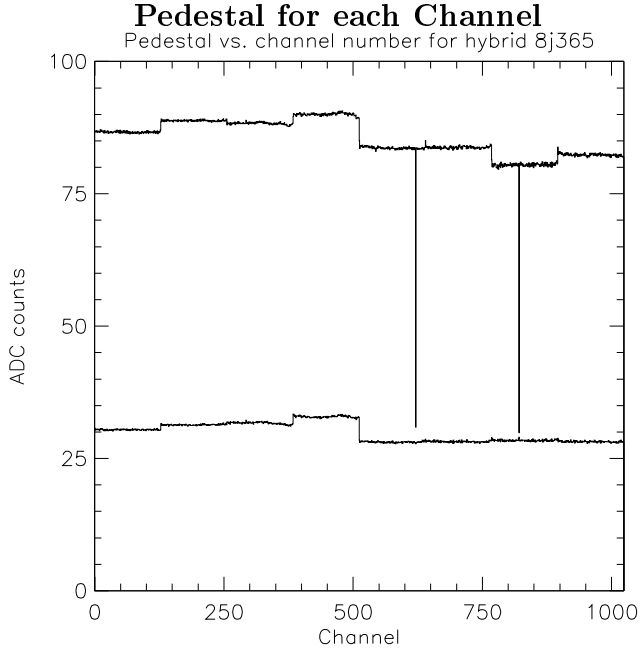
Pedestal for each Channel

The following plot shows the pedestals vs. channel number with and without charge injection:

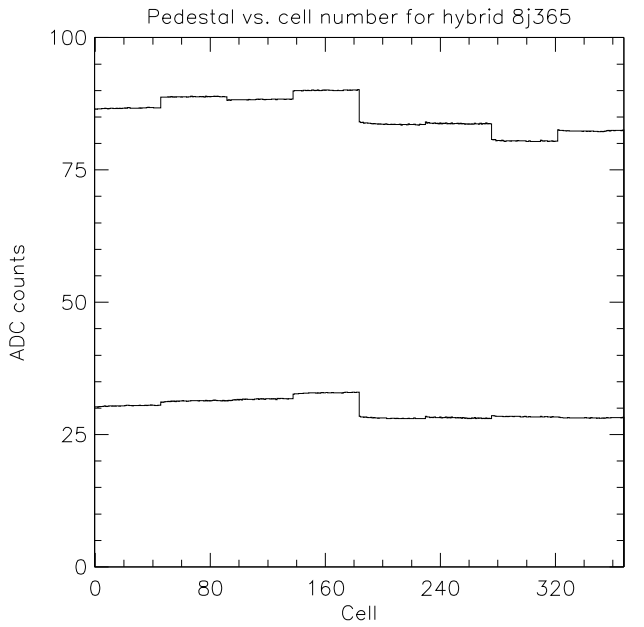
Pedestal vs. Pipeline Cell ID

The following plot shows the average pedestal vs. pipeline cell ID with and without charge injection. The x-axis is cell ID offset by 46 for each chip. Thus cell ID 5 for chip 1 is at x=5, chip 2 at x=51, chip 3 at x=97, etc.

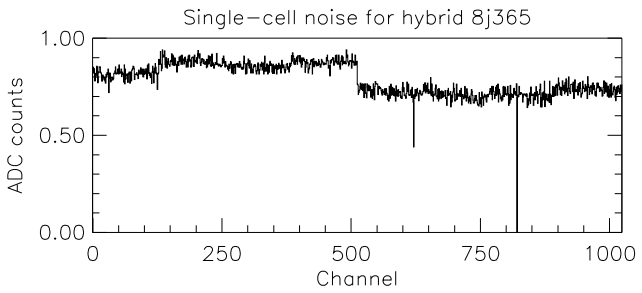
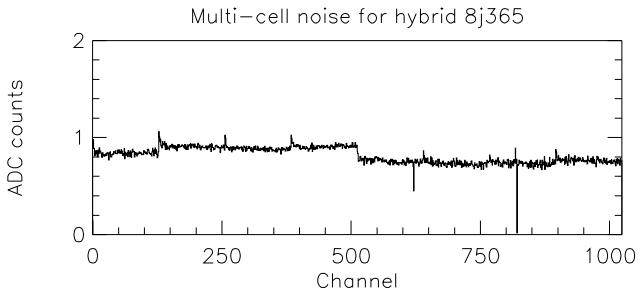
RMS Noise

The following plots show the single-cell and multi-cell RMS noise:

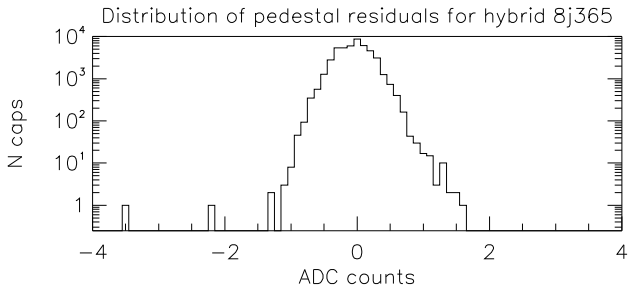
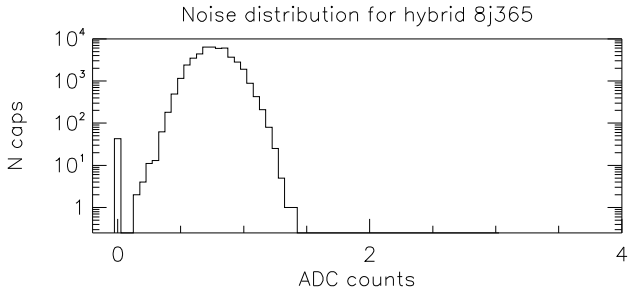
Distribution of Pedestals and Noise

The following are histograms of the pedestal of each pipeline capacitor relative to the chip average (top); and the RMS noise of each capacitor (bottom):

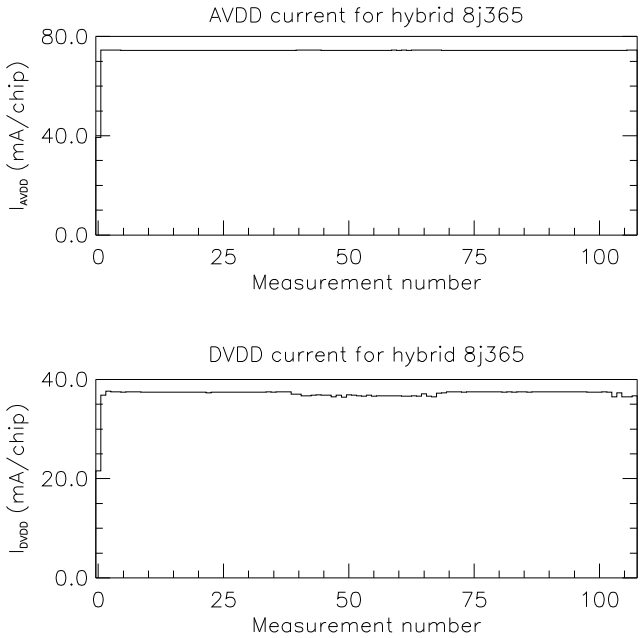
Supply Currents During Burn-in

The following plots show the supply currents per chip as a function of measurment number. Currents are measured approximately every 10 minutes:
