Hybrid 8j367 Traveler

July 20, 2000

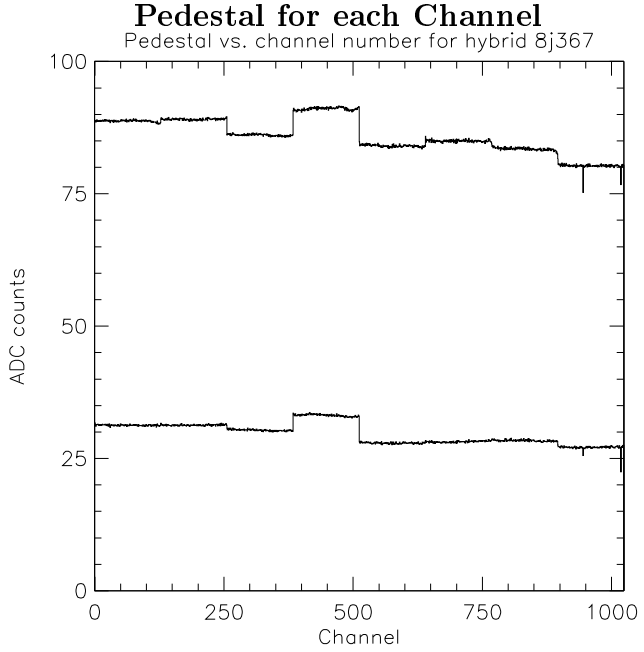
Pedestal for each Channel

The following plot shows the pedestals vs. channel number with and without charge injection:

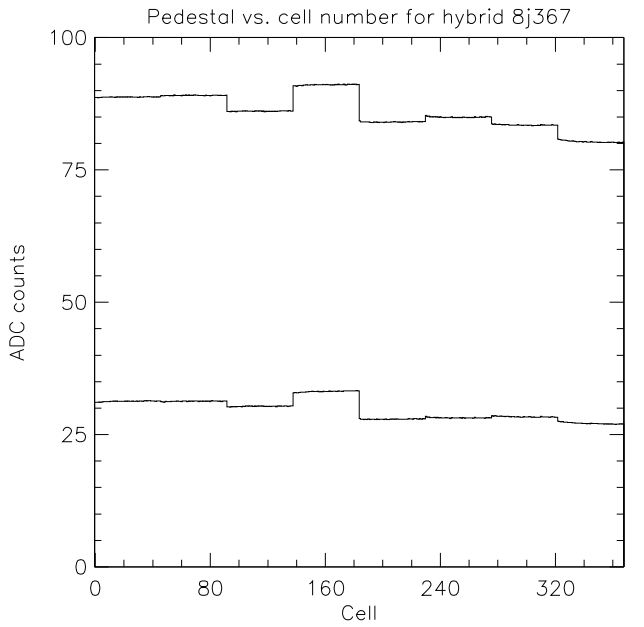
Pedestal vs. Pipeline Cell ID

The following plot shows the average pedestal vs. pipeline cell ID with and without charge injection. The x-axis is cell ID offset by 46 for each chip. Thus cell ID 5 for chip 1 is at x=5, chip 2 at x=51, chip 3 at x=97, etc.

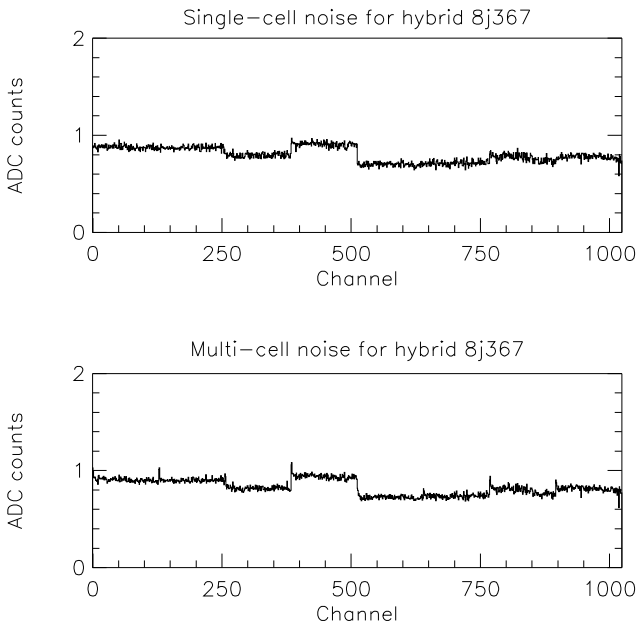
RMS Noise

The following plots show the single-cell and multi-cell RMS noise:

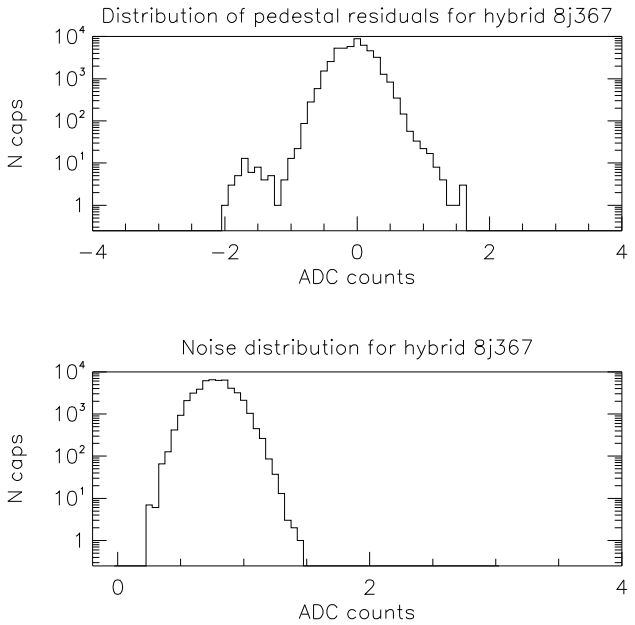
Distribution of Pedestals and Noise

The following are histograms of the pedestal of each pipeline capacitor relative to the chip average (top); and the RMS noise of each capacitor (bottom):

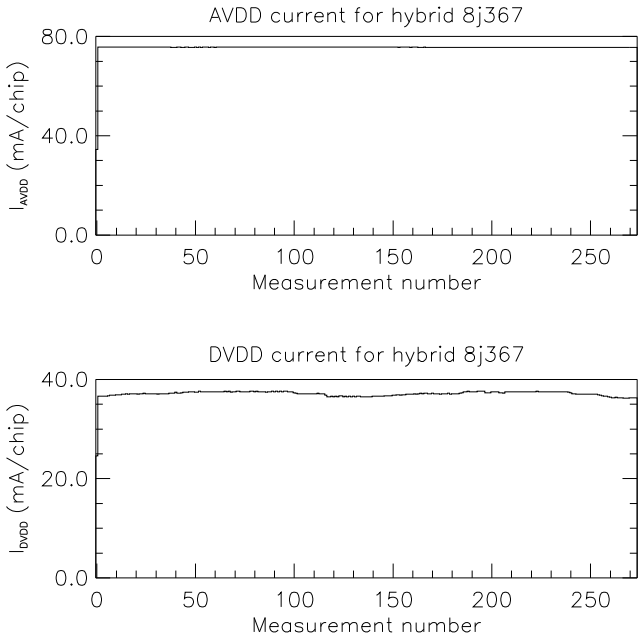
Supply Currents During Burn-in

The following plots show the supply currents per chip as a function of measurment number. Currents are measured approximately every 10 minutes:
