Hybrid 8j378 Traveler

August 4, 2000

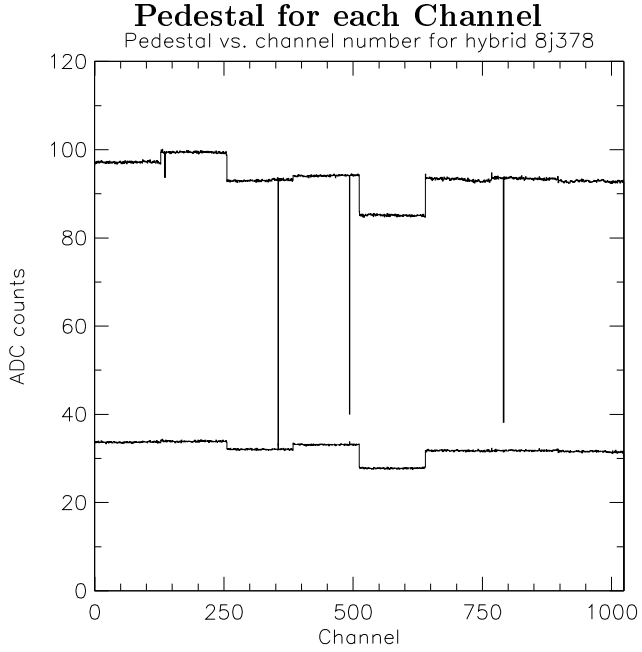
Pedestal for each Channel

The following plot shows the pedestals vs. channel number with and without charge injection:

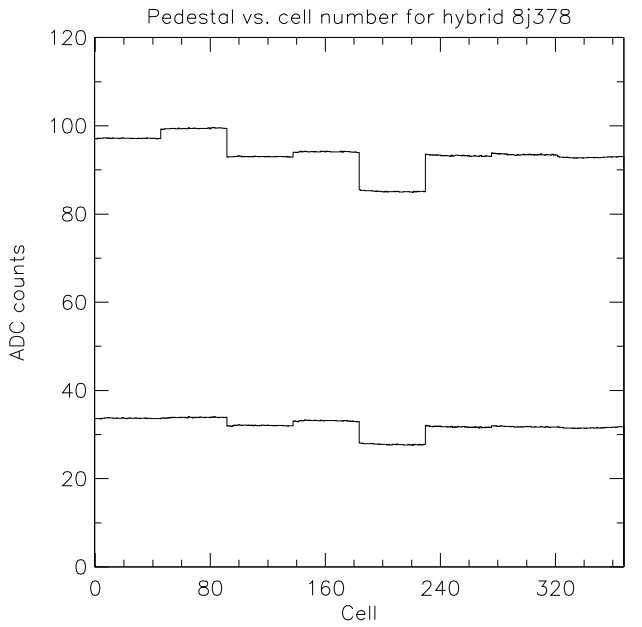
Pedestal vs. Pipeline Cell ID

The following plot shows the average pedestal vs. pipeline cell ID with and without charge injection. The x-axis is cell ID offset by 46 for each chip. Thus cell ID 5 for chip 1 is at x=5, chip 2 at x=51, chip 3 at x=97, etc.

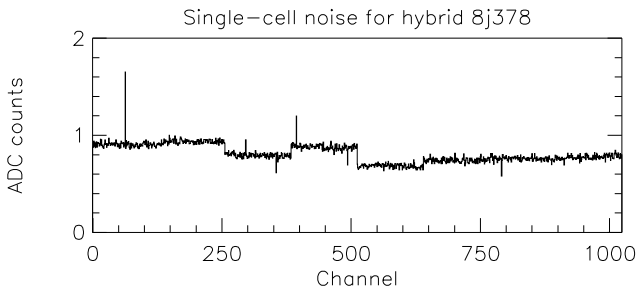
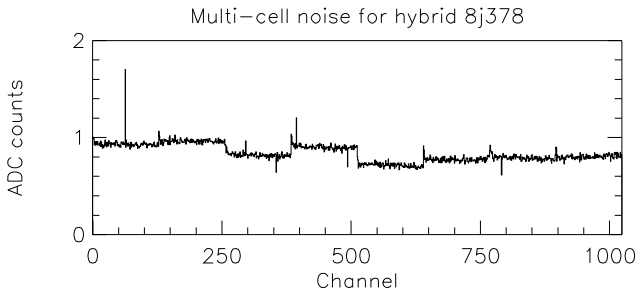
RMS Noise

The following plots show the single-cell and multi-cell RMS noise:

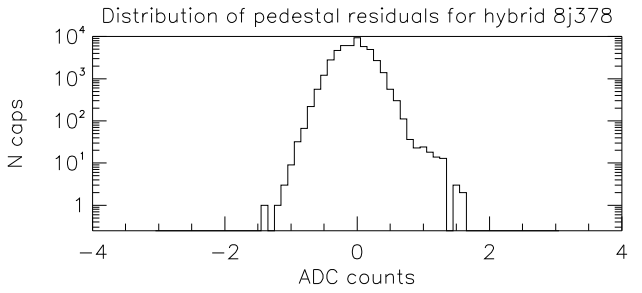
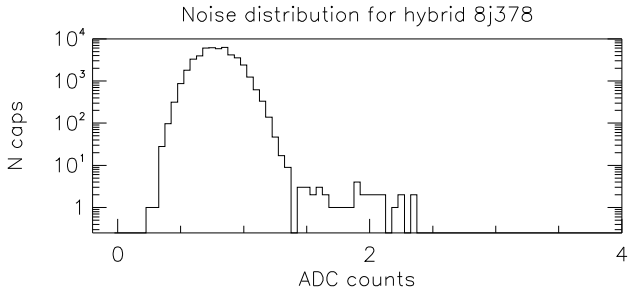
Distribution of Pedestals and Noise

The following are histograms of the pedestal of each pipeline capacitor relative to the chip average (top); and the RMS noise of each capacitor (bottom):

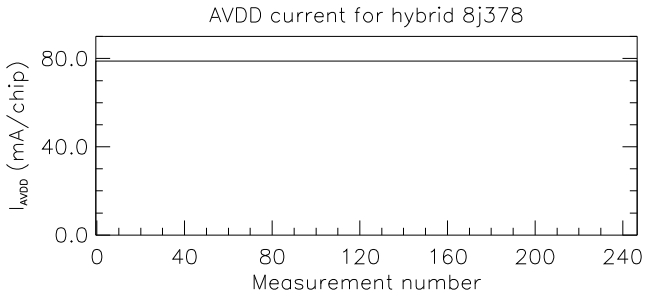
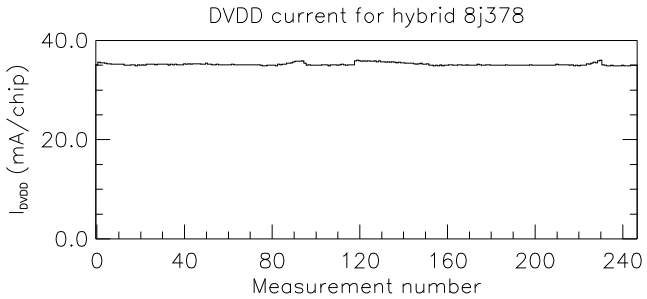
Supply Currents During Burn-in

The following plots show the supply currents per chip as a function of measurment number. Currents are measured approximately every 10 minutes:
