Hybrid 8j382 Traveler

July 13, 2000

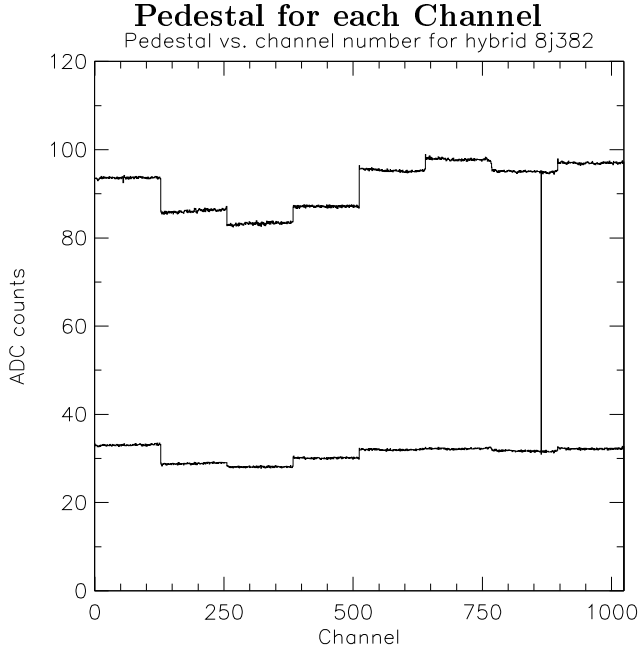
Pedestal for each Channel

The following plot shows the pedestals vs. channel number with and without charge injection:

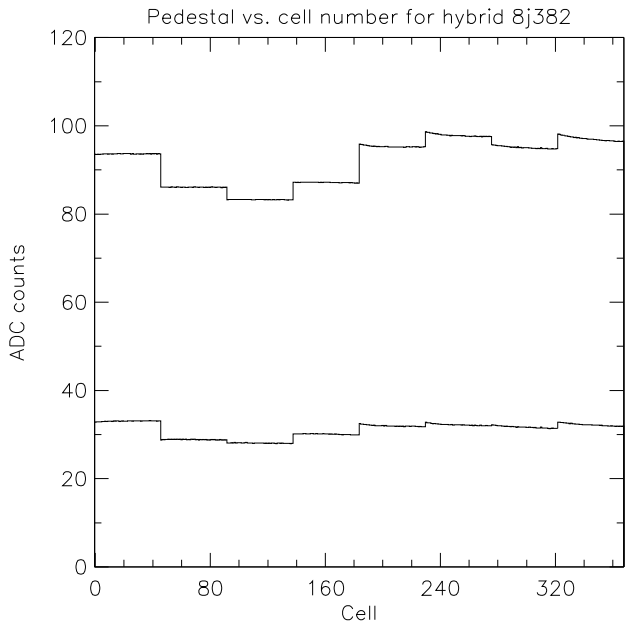
Pedestal vs. Pipeline Cell ID

The following plot shows the average pedestal vs. pipeline cell ID with and without charge injection. The x-axis is cell ID offset by 46 for each chip. Thus cell ID 5 for chip 1 is at x=5, chip 2 at x=51, chip 3 at x=97, etc.

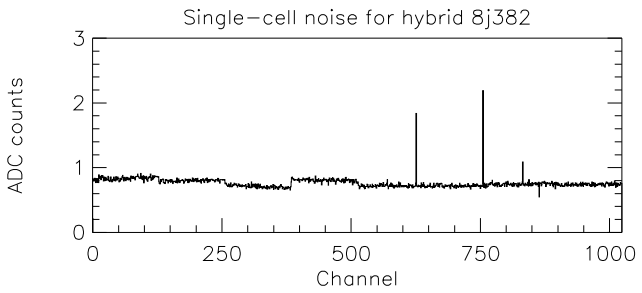
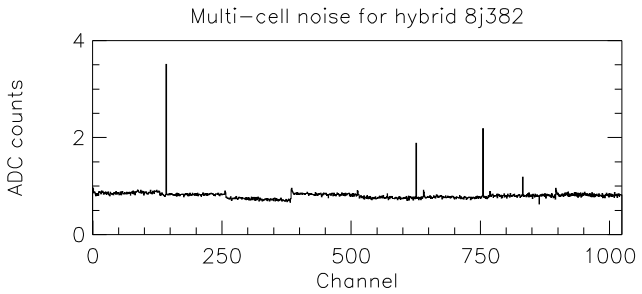
RMS Noise

The following plots show the single-cell and multi-cell RMS noise:

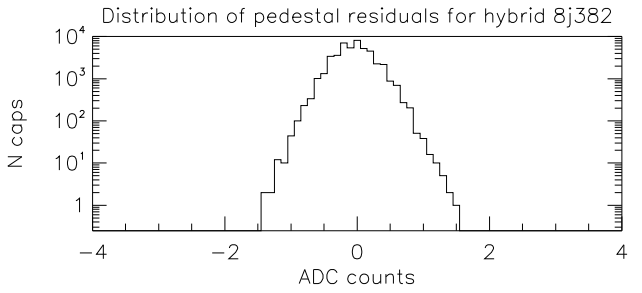
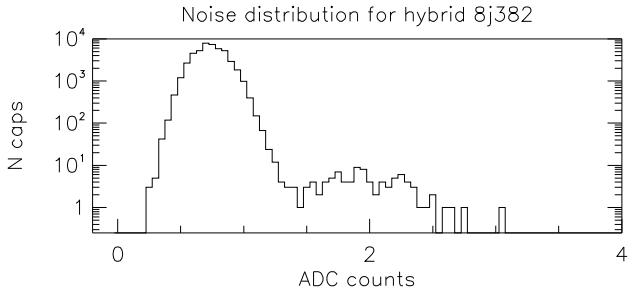
Distribution of Pedestals and Noise

The following are histograms of the pedestal of each pipeline capacitor relative to the chip average (top); and the RMS noise of each capacitor (bottom):

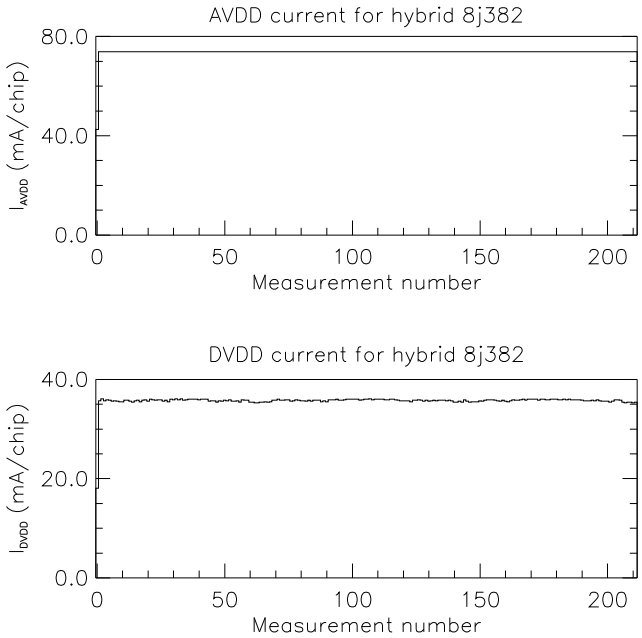
Supply Currents During Burn-in

The following plots show the supply currents per chip as a function of measurment number. Currents are measured approximately every 10 minutes:
