Hybrid 8j39 Traveler

October 29, 1999

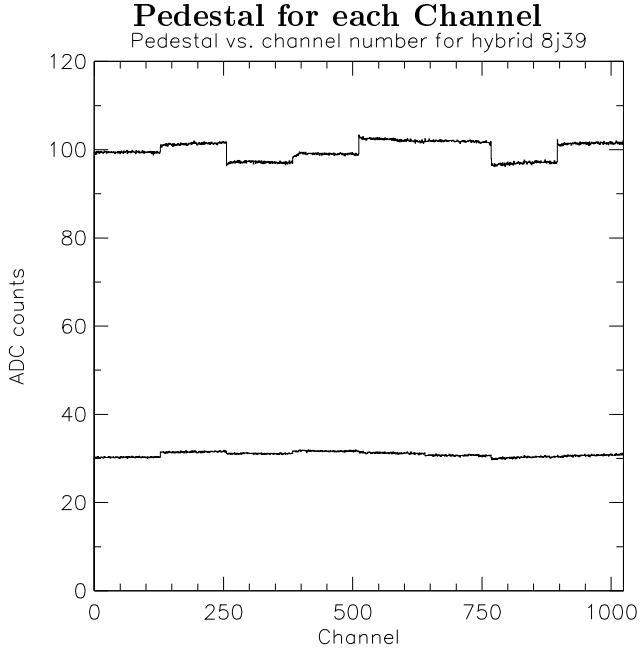
Pedestal for each Channel

The following plot shows the pedestals vs. channel number with and without charge injection:

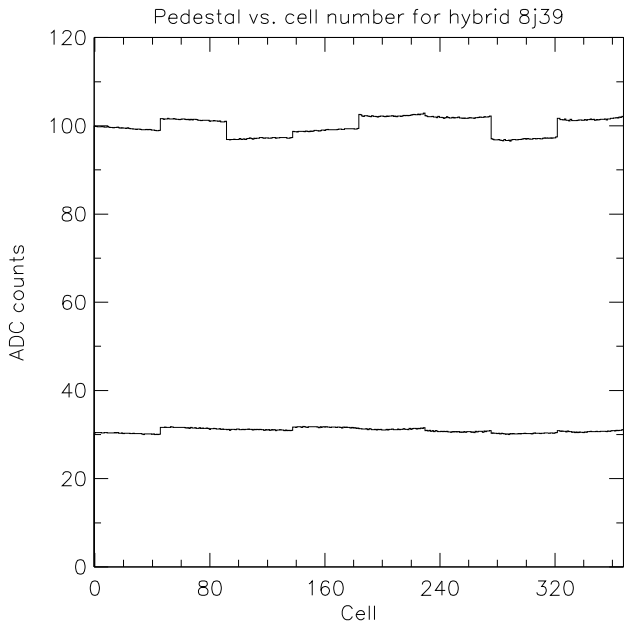
Pedestal vs. Pipeline Cell ID

The following plot shows the average pedestal vs. pipeline cell ID with and without charge injection. The x-axis is cell ID offset by 46 for each chip. Thus cell ID 5 for chip 1 is at x=5, chip 2 at x=51, chip 3 at x=97, etc.

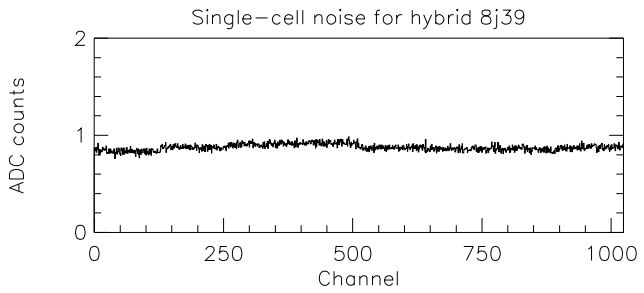
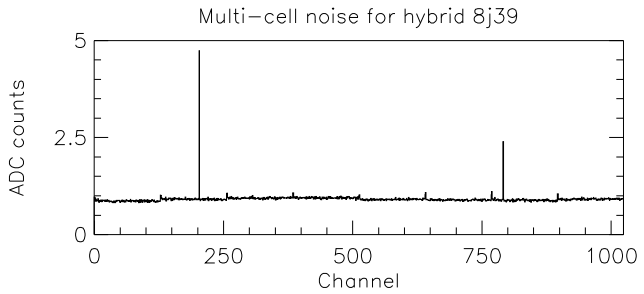
RMS Noise

The following plots show the single-cell and multi-cell RMS noise:

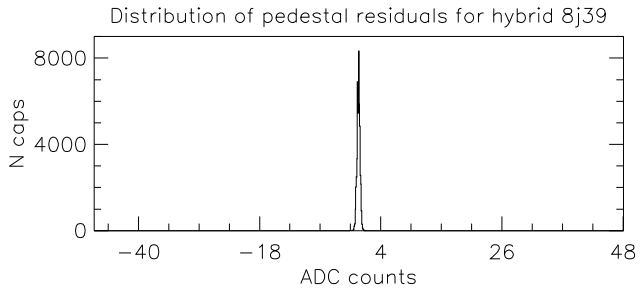
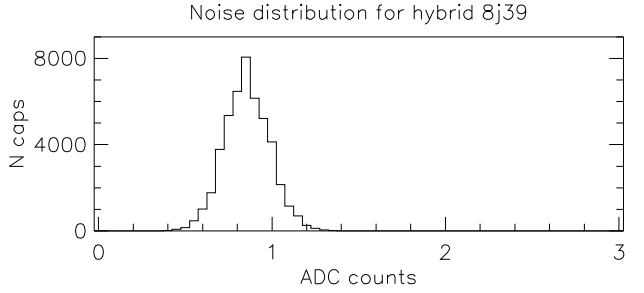
Distribution of Pedestals and Noise

The following are histograms of the pedestal of each pipeline capacitor relative to the chip average (top); and the RMS noise of each capacitor (bottom):

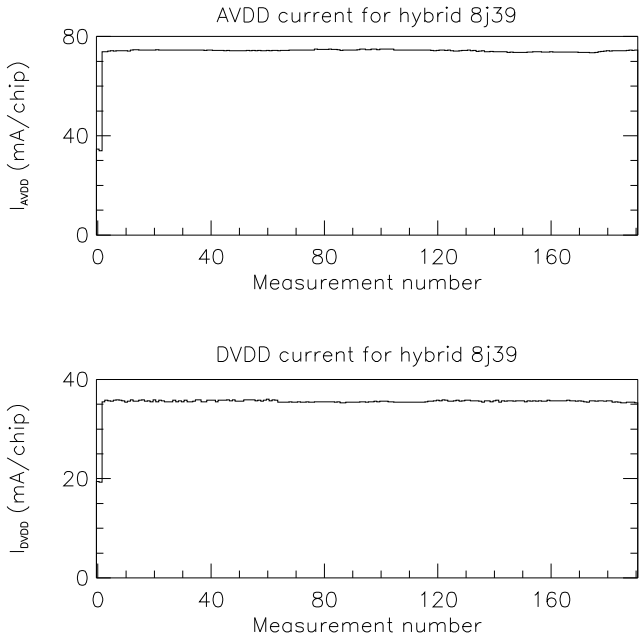
Supply Currents During Burn-in

The following plots show the supply currents per chip as a function of measurment number. Currents are measured approximately every 10 minutes:
