Hybrid 8j391 Traveler

July 24, 2000

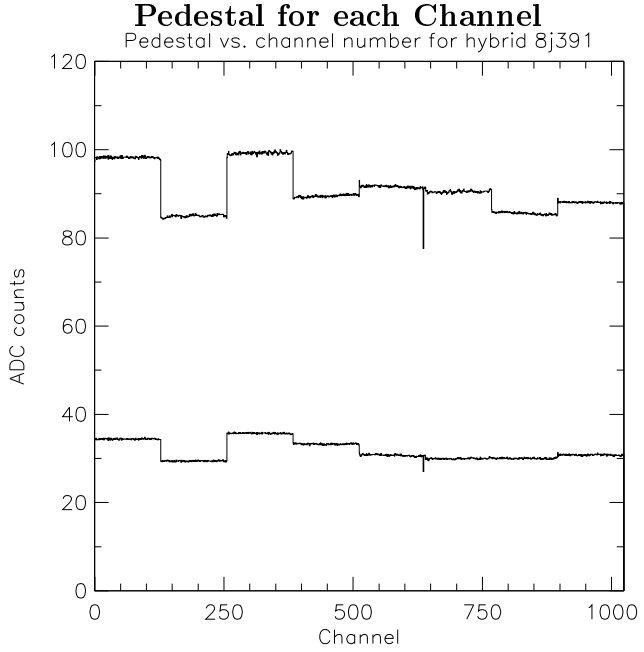
Pedestal for each Channel

The following plot shows the pedestals vs. channel number with and without charge injection:

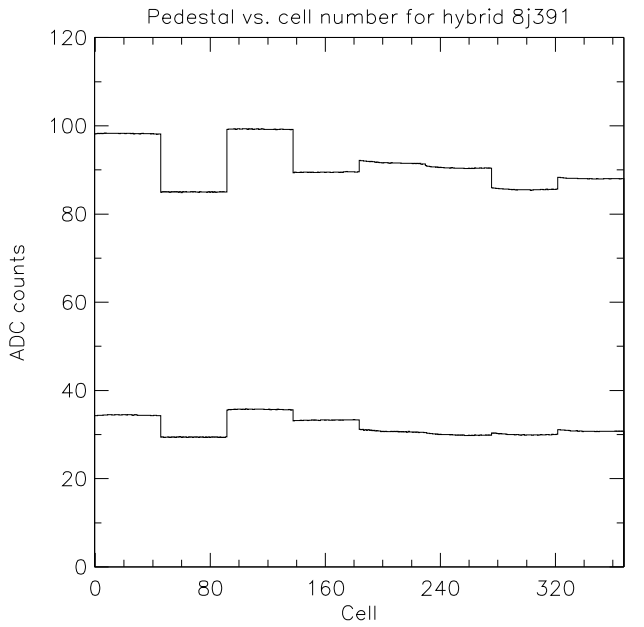
Pedestal vs. Pipeline Cell ID

The following plot shows the average pedestal vs. pipeline cell ID with and without charge injection. The x-axis is cell ID offset by 46 for each chip. Thus cell ID 5 for chip 1 is at x=5, chip 2 at x=51, chip 3 at x=97, etc.

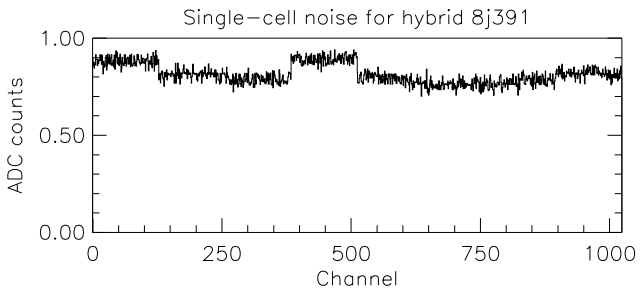
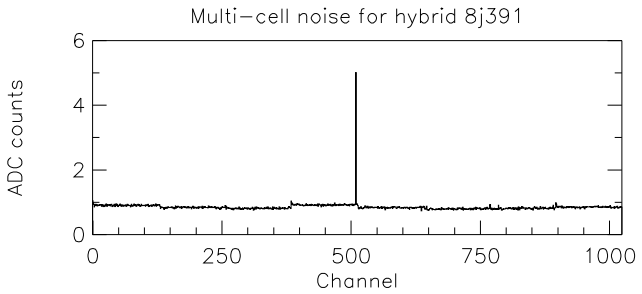
RMS Noise

The following plots show the single-cell and multi-cell RMS noise:

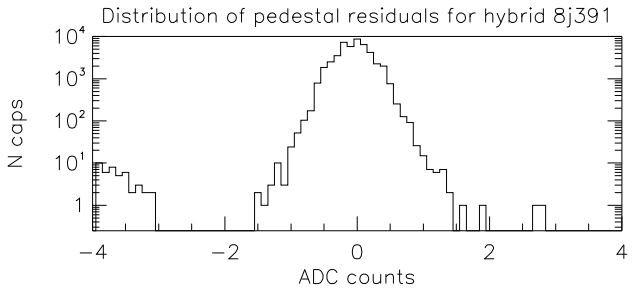
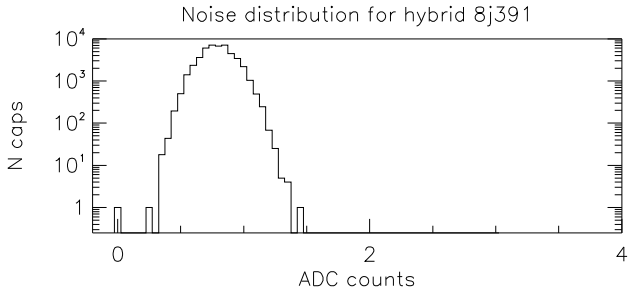
Distribution of Pedestals and Noise

The following are histograms of the pedestal of each pipeline capacitor relative to the chip average (top); and the RMS noise of each capacitor (bottom):

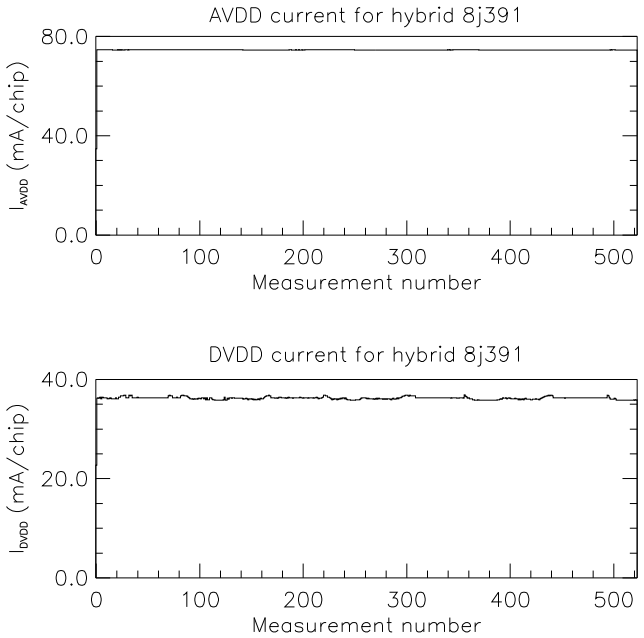
Supply Currents During Burn-in

The following plots show the supply currents per chip as a function of measurment number. Currents are measured approximately every 10 minutes:
