Hybrid 8j397 Traveler

July 17, 2000

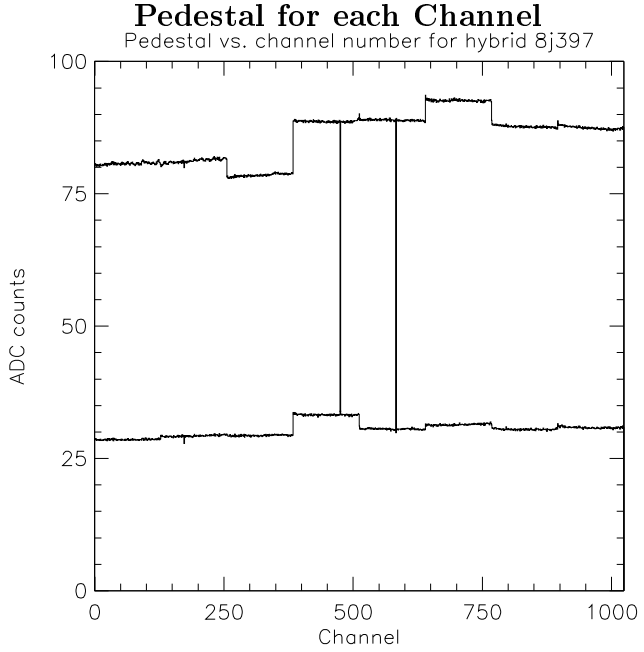
Pedestal for each Channel

The following plot shows the pedestals vs. channel number with and without charge injection:

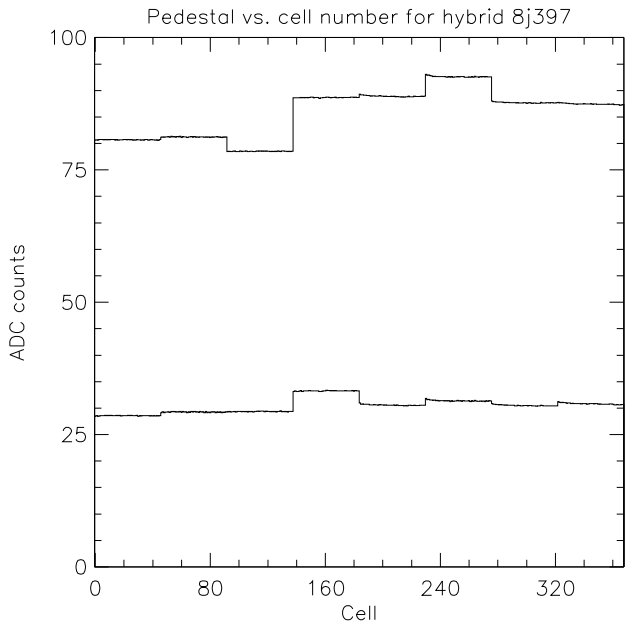
Pedestal vs. Pipeline Cell ID

The following plot shows the average pedestal vs. pipeline cell ID with and without charge injection. The x-axis is cell ID offset by 46 for each chip. Thus cell ID 5 for chip 1 is at x=5, chip 2 at x=51, chip 3 at x=97, etc.

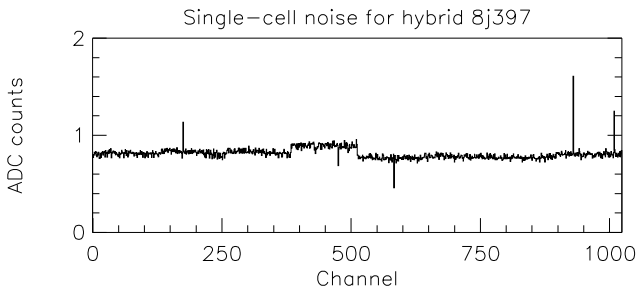
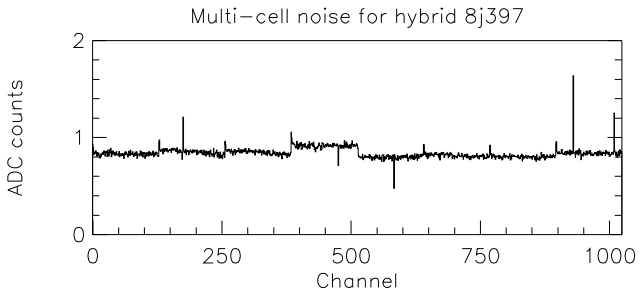
RMS Noise

The following plots show the single-cell and multi-cell RMS noise:

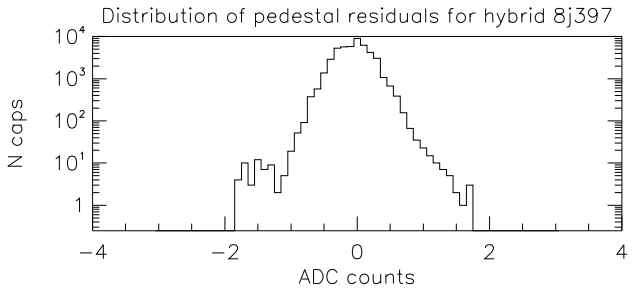
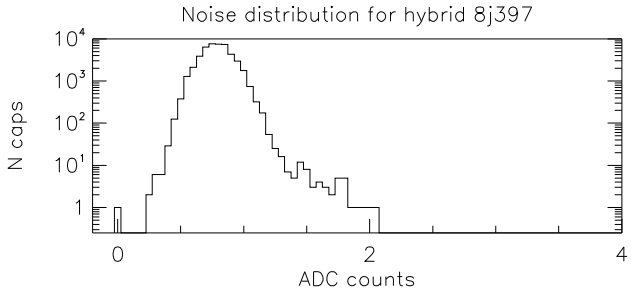
Distribution of Pedestals and Noise

The following are histograms of the pedestal of each pipeline capacitor relative to the chip average (top); and the RMS noise of each capacitor (bottom):

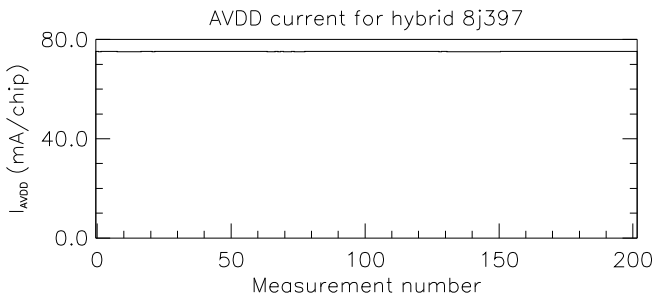
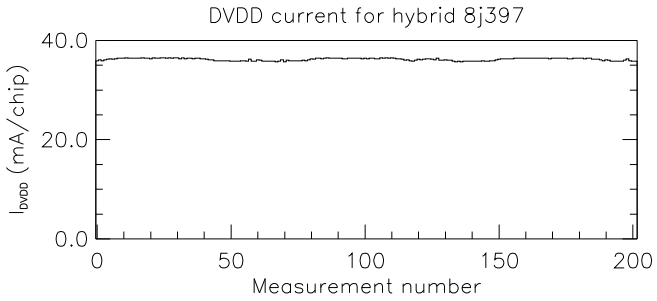
Supply Currents During Burn-in

The following plots show the supply currents per chip as a function of measurment number. Currents are measured approximately every 10 minutes:
