Hybrid 8j41 Traveler

January 31, 2000

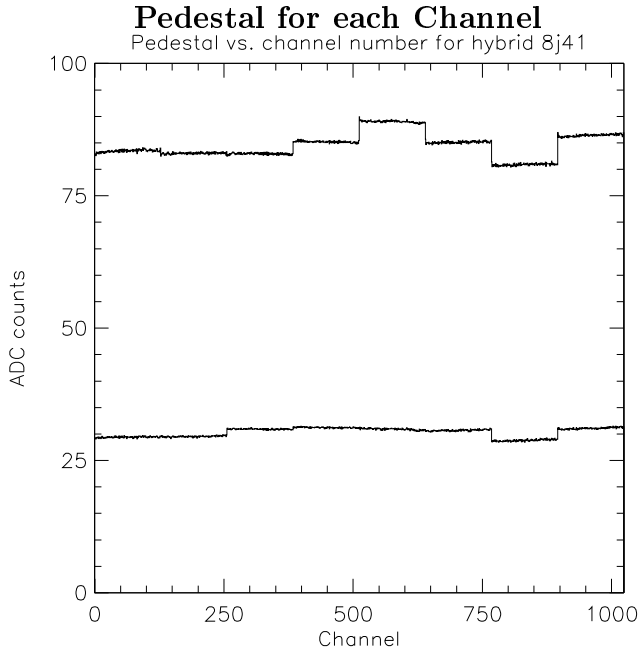
The following plot shows the pedestals vs. channel number with and without charge injection:

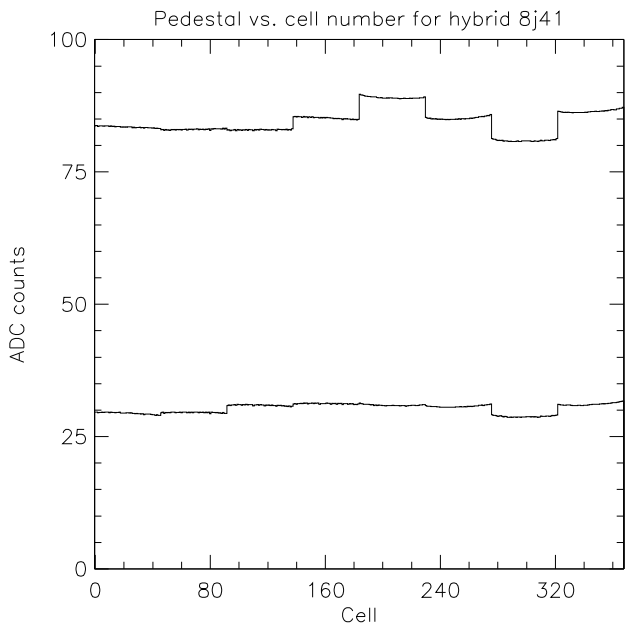
The following plot shows the average pedestal vs. pipeline cell ID with and without charge injection. The x-axis is cell ID offset by 46 for each chip. Thus cell ID 5 for chip 1 is at x=5, chip 2 at x=51, chip 3 at x=97, etc.

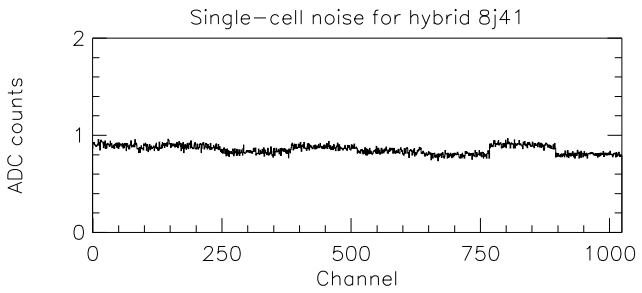
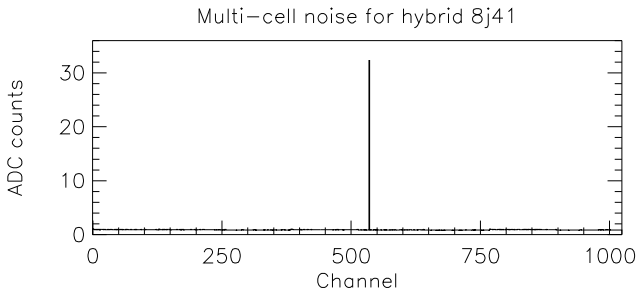
RMS Noise

The following plots show the single-cell and multi-cell RMS noise:

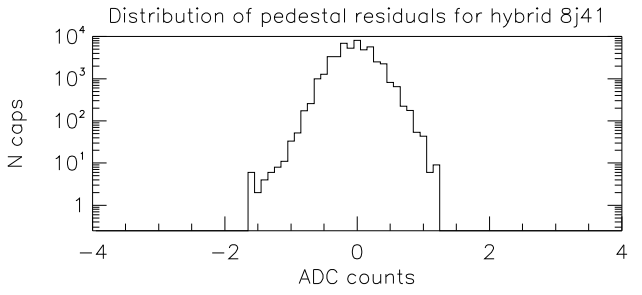
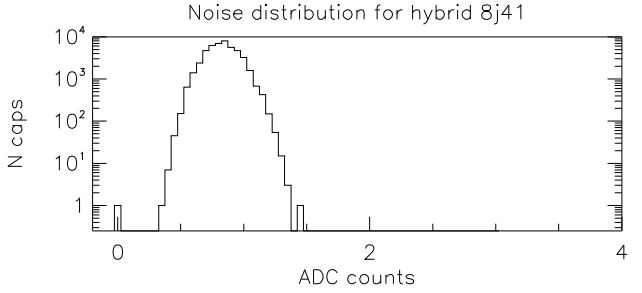
Distribution of Pedestals and Noise

The following are histograms of the pedestal of each pipeline capacitor relative to the chip average (top); and the RMS noise of each capacitor (bottom):

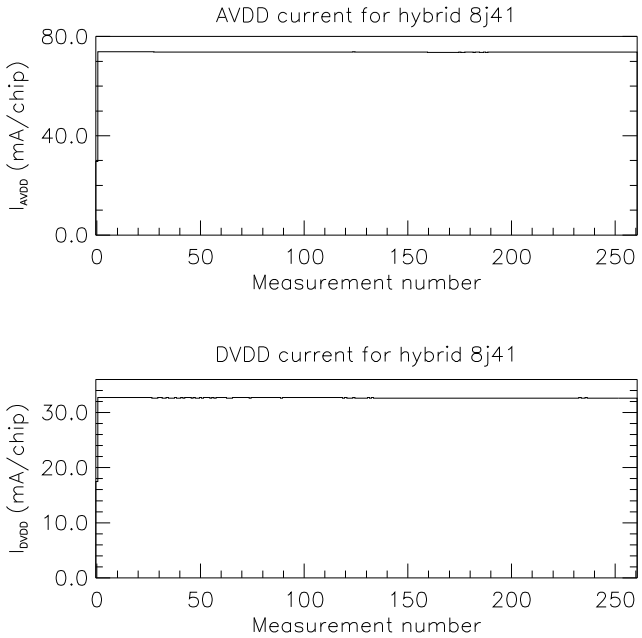
Supply Currents During Burn-in

The following plots show the supply currents per chip as a function of measurment number. Currents are measured approximately every 10 minutes:
