Hybrid 8j426 Traveler

June 26, 2000

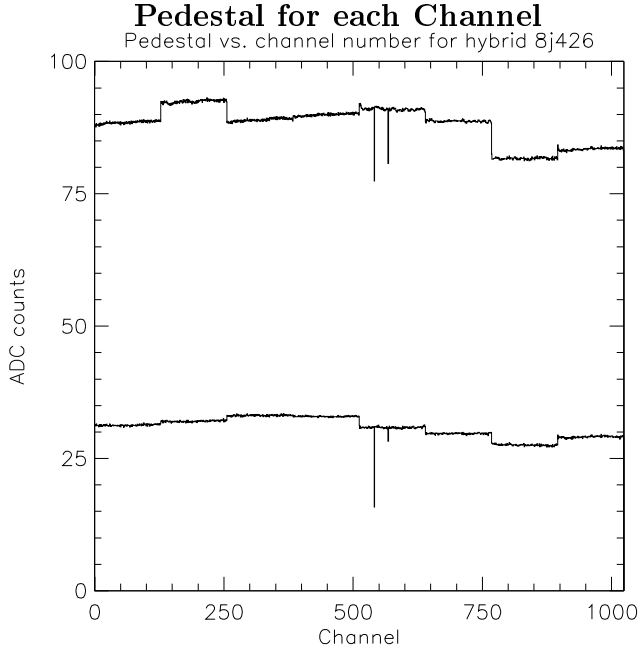
Pedestal for each Channel

The following plot shows the pedestals vs. channel number with and without charge injection:

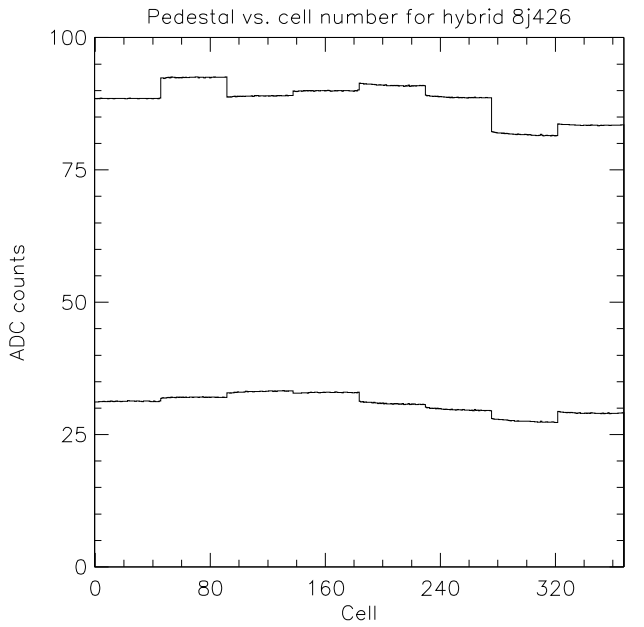
Pedestal vs. Pipeline Cell ID

The following plot shows the average pedestal vs. pipeline cell ID with and without charge injection. The x-axis is cell ID offset by 46 for each chip. Thus cell ID 5 for chip 1 is at x=5, chip 2 at x=51, chip 3 at x=97, etc.

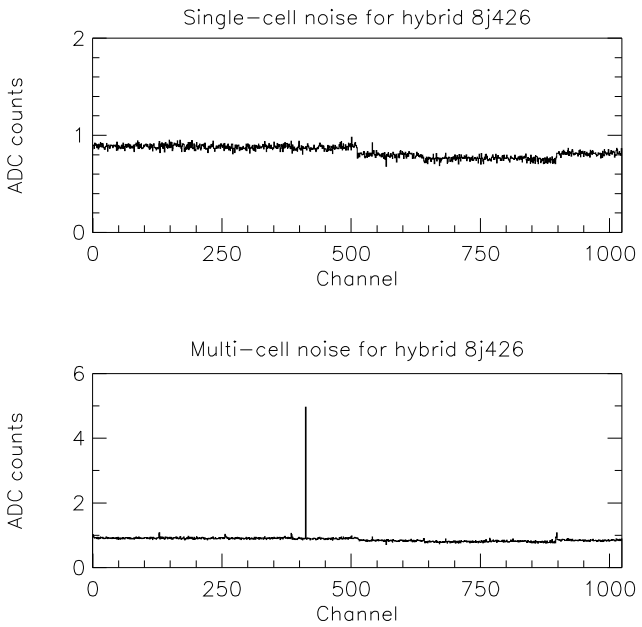
RMS Noise

The following plots show the single-cell and multi-cell RMS noise:

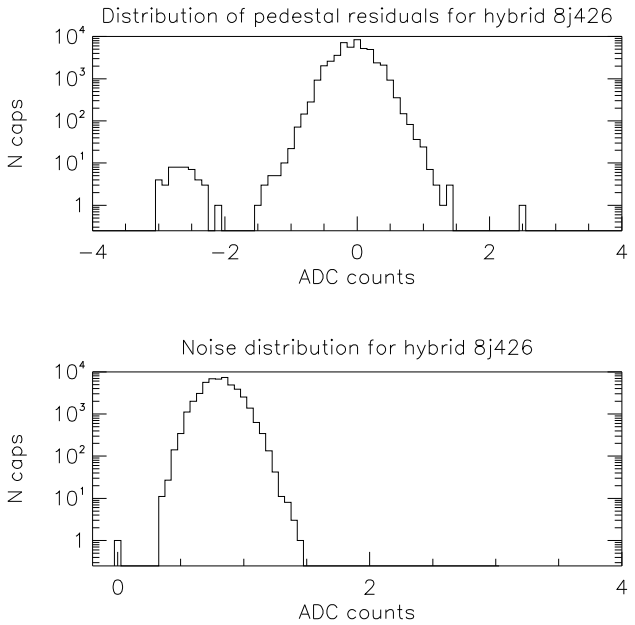
Distribution of Pedestals and Noise

The following are histograms of the pedestal of each pipeline capacitor relative to the chip average (top); and the RMS noise of each capacitor (bottom):

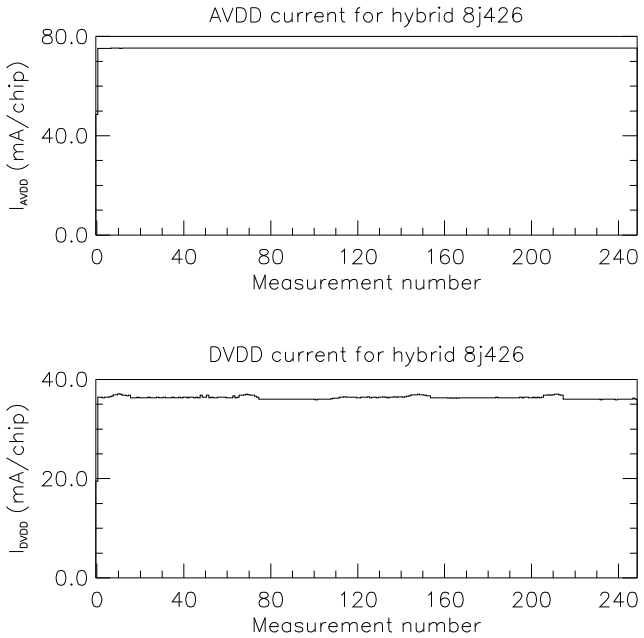
Supply Currents During Burn-in

The following plots show the supply currents per chip as a function of measurment number. Currents are measured approximately every 10 minutes:
