Hybrid 8j44 Traveler

December 20, 1999

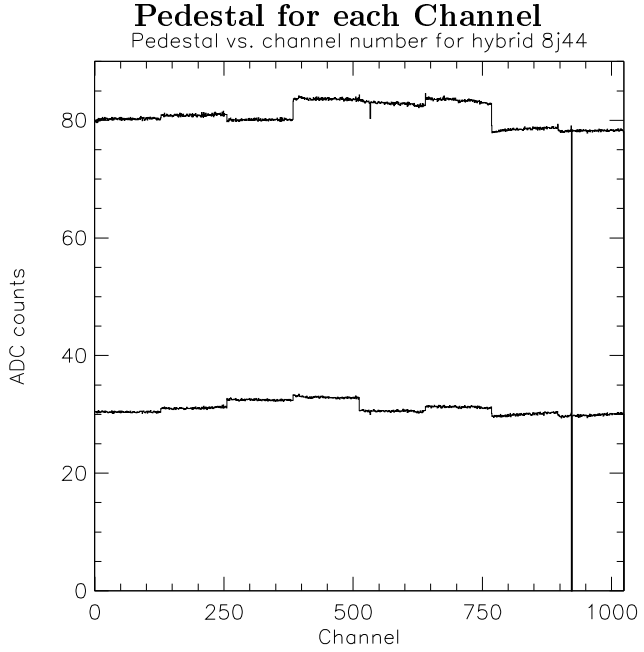
The following plot shows the pedestals vs. channel number with and without charge injection:

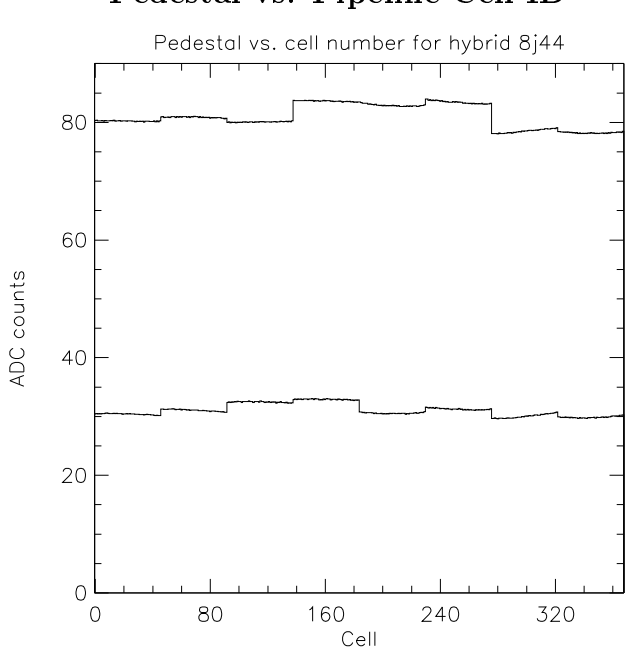
The following plot shows the average pedestal vs. pipeline cell ID with and without charge injection. The x-axis is cell ID offset by 46 for each chip. Thus cell ID 5 for chip 1 is at x=5, chip 2 at x=51, chip 3 at x=97, etc.

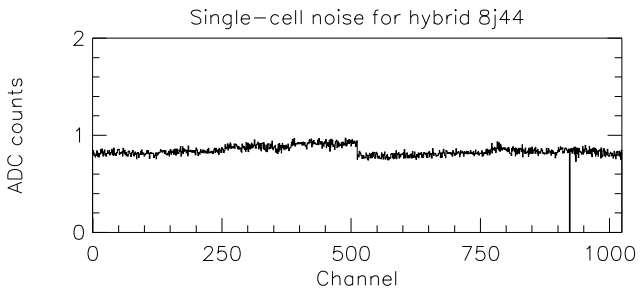
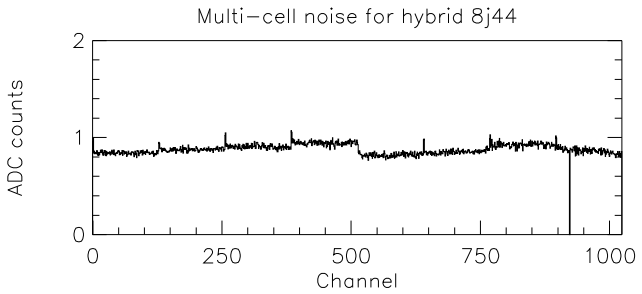
RMS Noise

The following plots show the single-cell and multi-cell RMS noise:

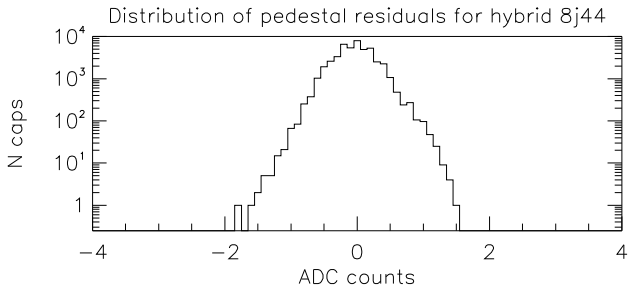
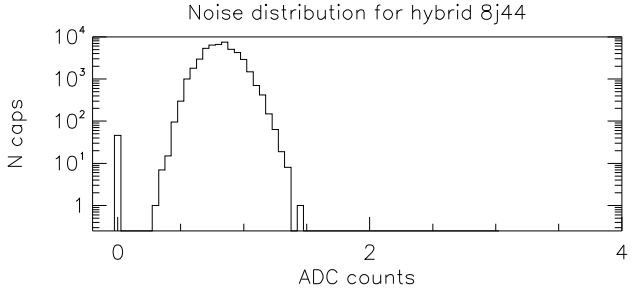
Distribution of Pedestals and Noise

The following are histograms of the pedestal of each pipeline capacitor relative to the chip average (top); and the RMS noise of each capacitor (bottom):

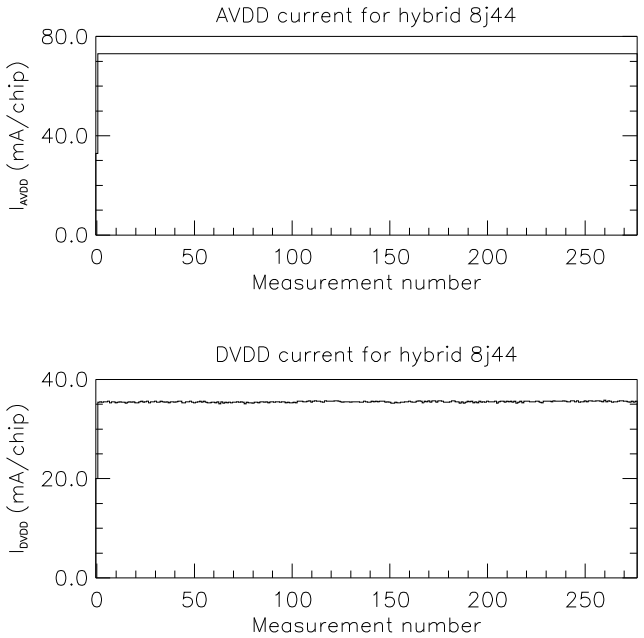
Supply Currents During Burn-in

The following plots show the supply currents per chip as a function of measurment number. Currents are measured approximately every 10 minutes:
