Hybrid 8j53 Traveler

November 2, 1999

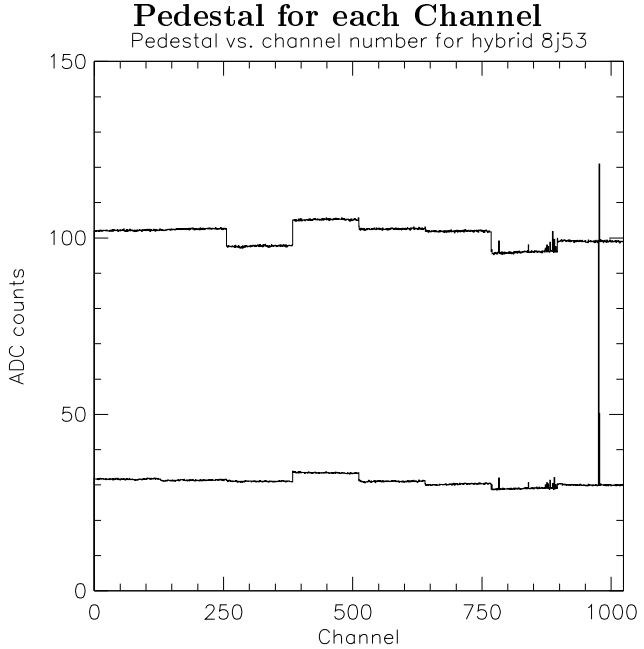
Pedestal for each Channel

Hybrid 8j53 quality: bad
Chip classification: good good good good good good fair bad
Bad channels (chip-channel): 6-72 6-114 7-78 7-80 7-81 7-82
Bad cells: none
Random bad capacitors (chip-cell-channel): 6-42-114 6-44-114 6-45-114 6-45-122
Channels at pedestal needed for DCMS: 34.1 34.6 34.6 33.6 33.1 33.6 33.6 32.6
```
