Hybrid 8j54 Traveler

November 2, 1999

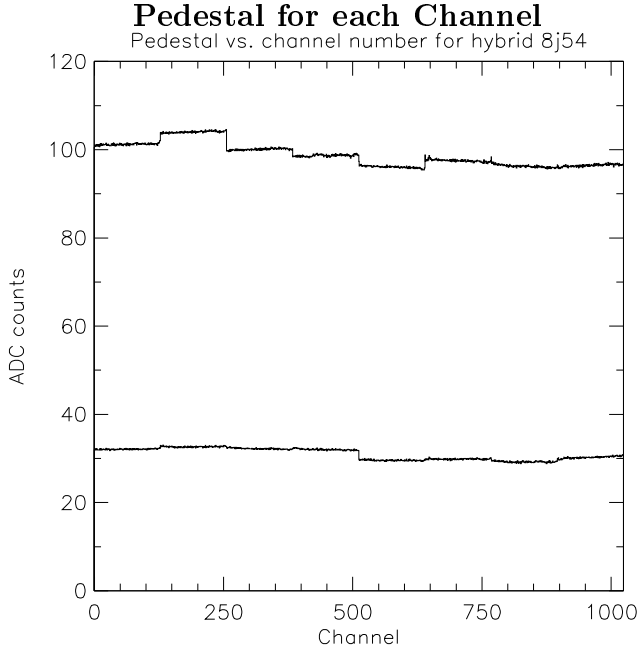
Pedestal for each Channel

The following plot shows the pedestals vs. channel number with and without charge injection:

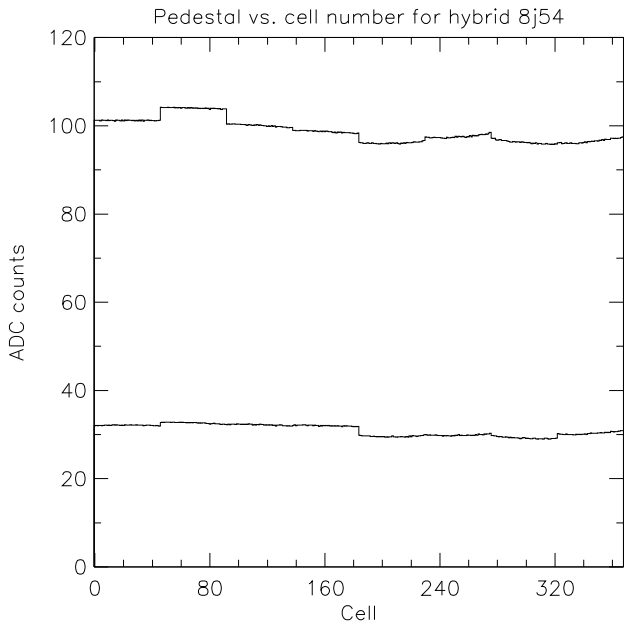
Pedestal vs. Pipeline Cell ID

The following plot shows the average pedestal vs. pipeline cell ID with and without charge injection. The x-axis is cell ID offset by 46 for each chip. Thus cell ID 5 for chip 1 is at x=5, chip 2 at x=51, chip 3 at x=97, etc.

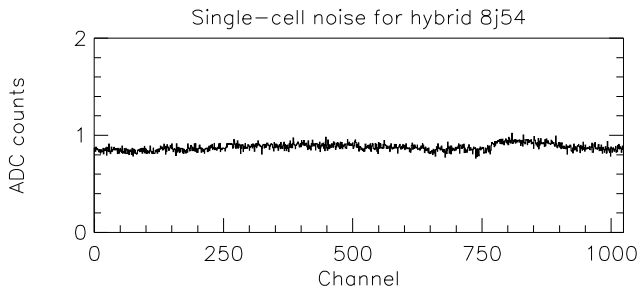
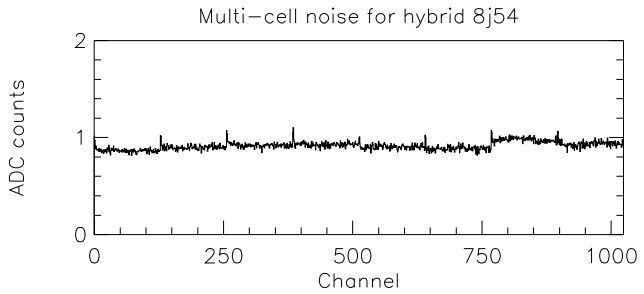
RMS Noise

The following plots show the single-cell and multi-cell RMS noise:

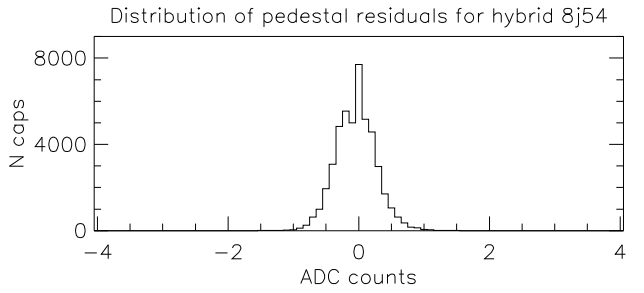
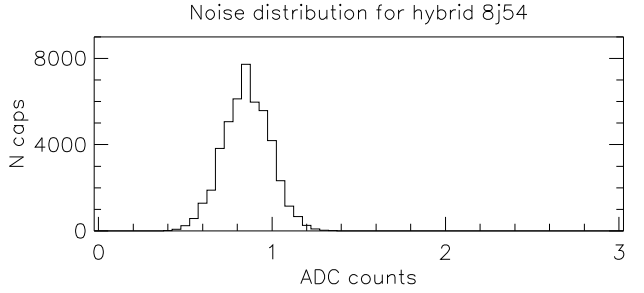
Distribution of Pedestals and Noise

The following are histograms of the pedestal of each pipeline capacitor relative to the chip average (top); and the RMS noise of each capacitor (bottom):

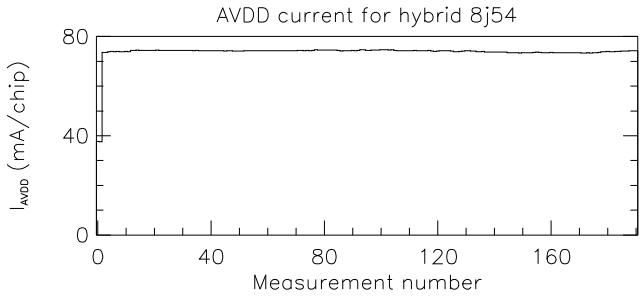
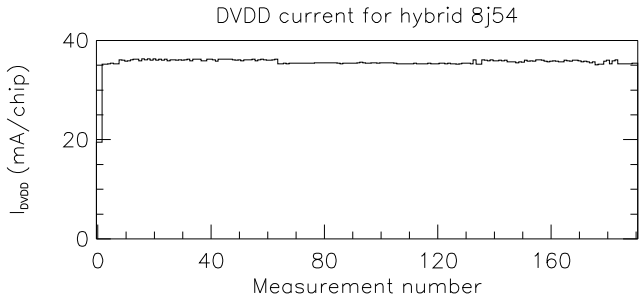
Supply Currents During Burn-in

The following plots show the supply currents per chip as a function of measurment number. Currents are measured approximately every 10 minutes:
