Hybrid 8j57 Traveler

November 2, 1999

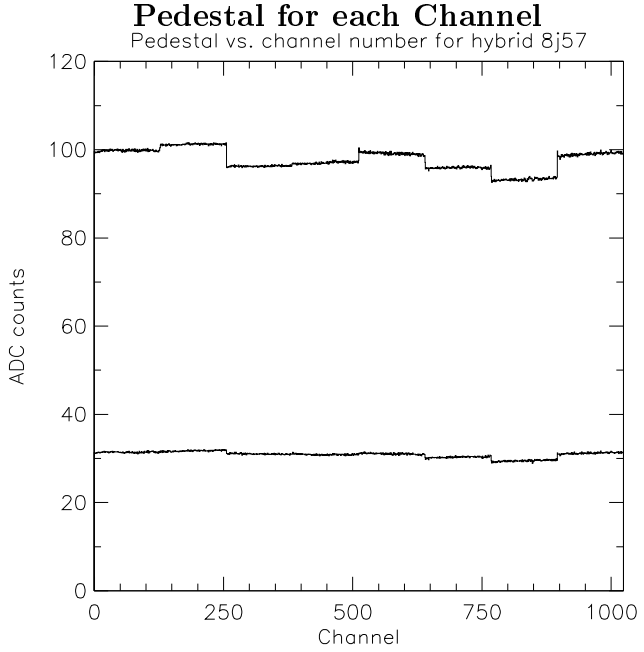
Pedestal for each Channel

The following plot shows the pedestals vs. channel number with and without charge injection:

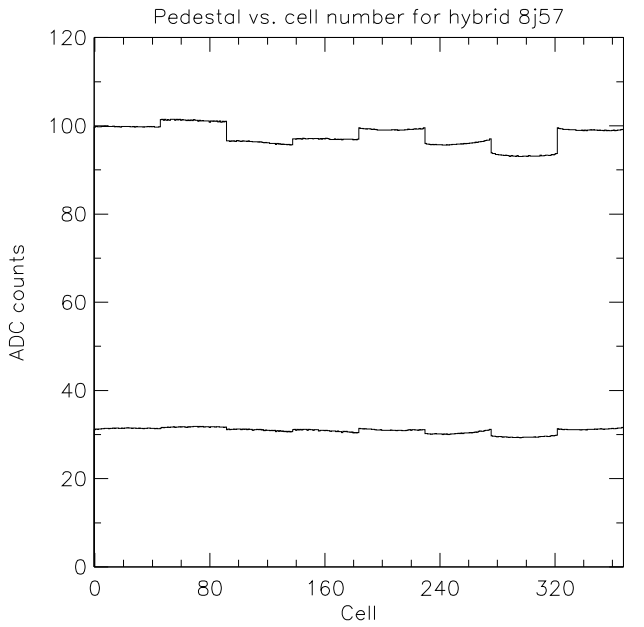
Pedestal vs. Pipeline Cell ID

The following plot shows the average pedestal vs. pipeline cell ID with and without charge injection. The x-axis is cell ID offset by 46 for each chip. Thus cell ID 5 for chip 1 is at x=5, chip 2 at x=51, chip 3 at x=97, etc.

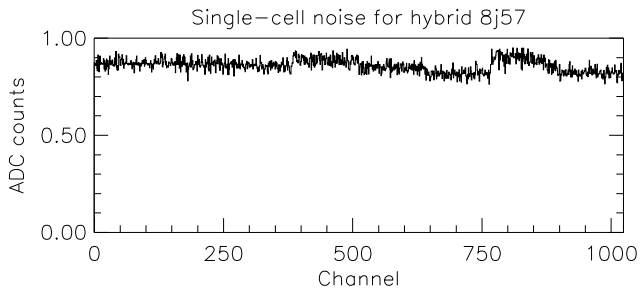
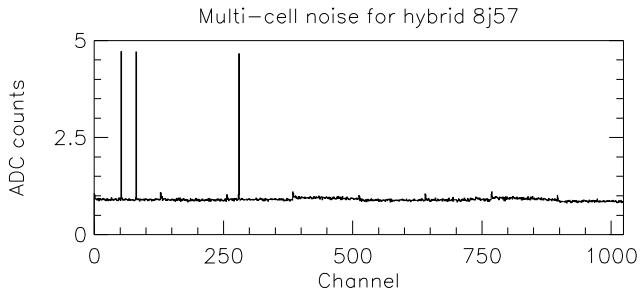
RMS Noise

The following plots show the single-cell and multi-cell RMS noise:

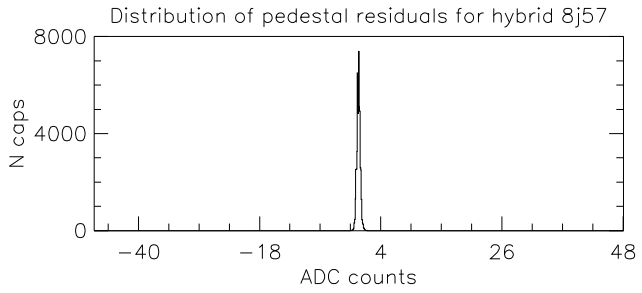
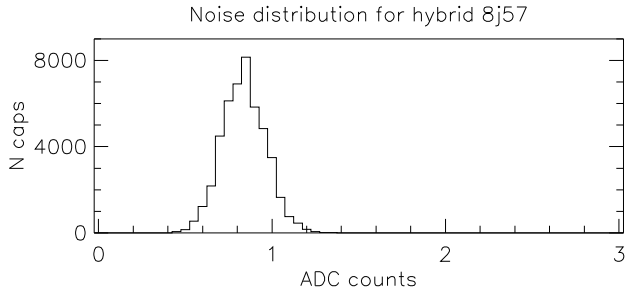
Distribution of Pedestals and Noise

The following are histograms of the pedestal of each pipeline capacitor relative to the chip average (top); and the RMS noise of each capacitor (bottom):

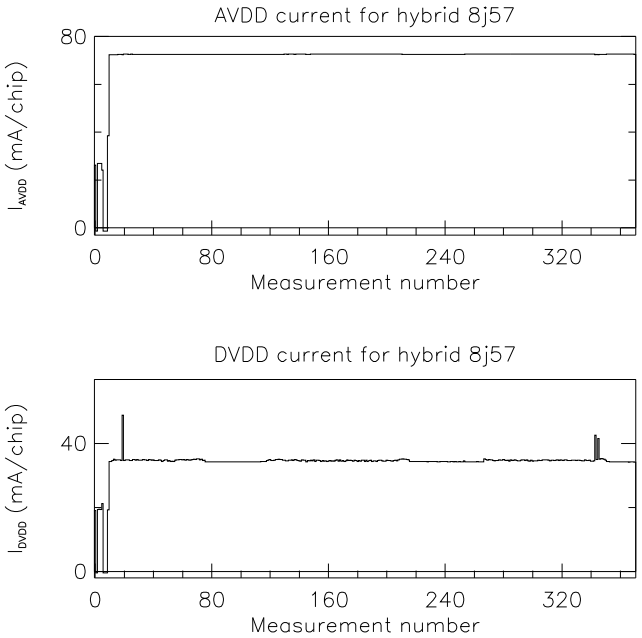
Supply Currents During Burn-in

The following plots show the supply currents per chip as a function of measurment number. Currents are measured approximately every 10 minutes:
