Hybrid 8j62 Traveler

November 9, 1999

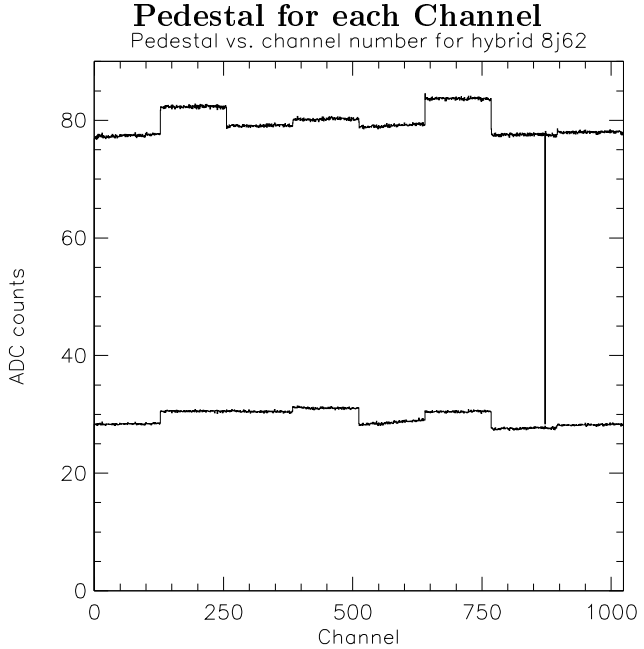
Pedestal for each Channel

The following plot shows the pedestals vs. channel number with and without charge injection:

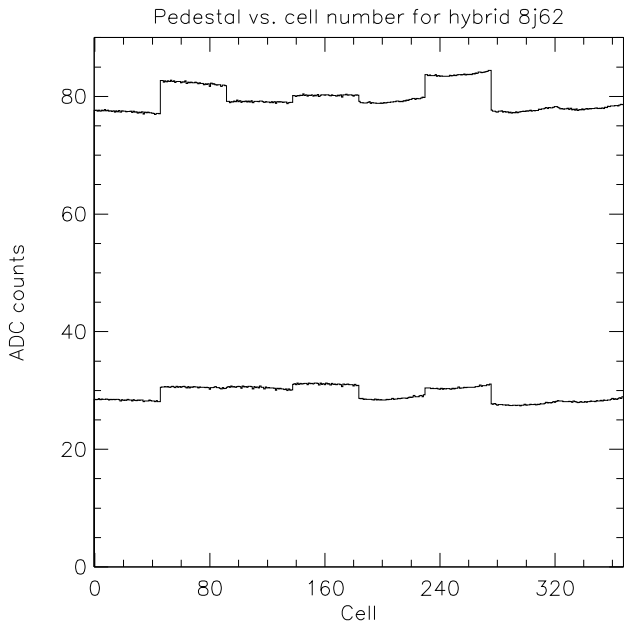
Pedestal vs. Pipeline Cell ID

The following plot shows the average pedestal vs. pipeline cell ID with and without charge injection. The x-axis is cell ID offset by 46 for each chip. Thus cell ID 5 for chip 1 is at x=5, chip 2 at x=51, chip 3 at x=97, etc.

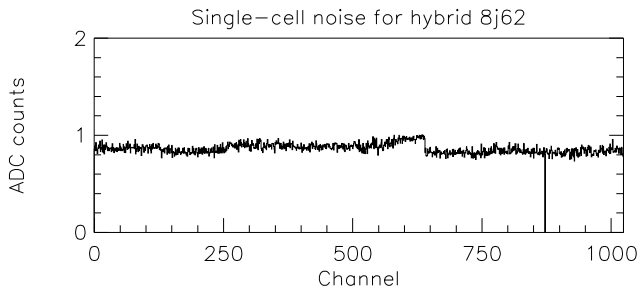
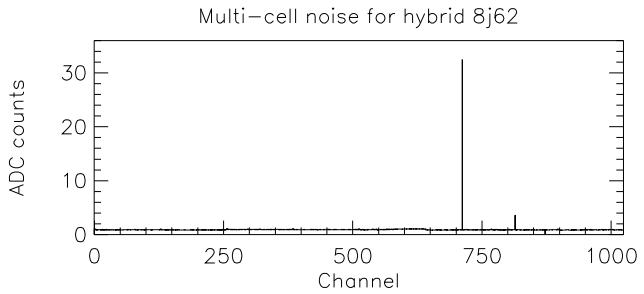
RMS Noise

The following plots show the single-cell and multi-cell RMS noise:

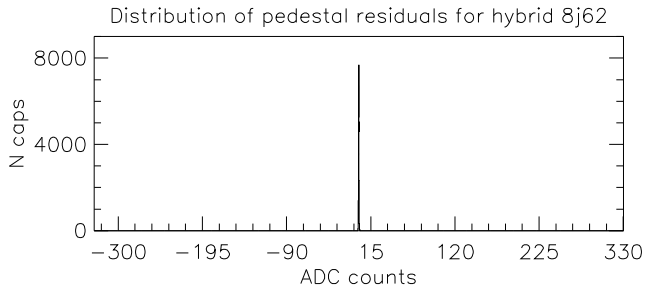
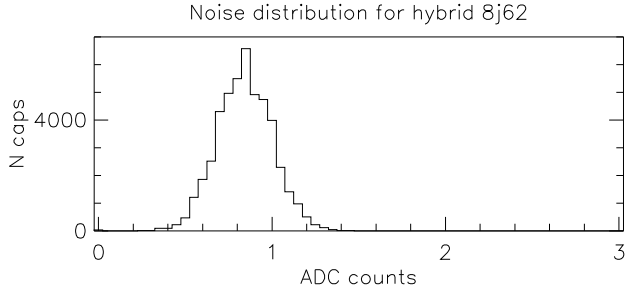
Distribution of Pedestals and Noise

The following are histograms of the pedestal of each pipeline capacitor relative to the chip average (top); and the RMS noise of each capacitor (bottom):

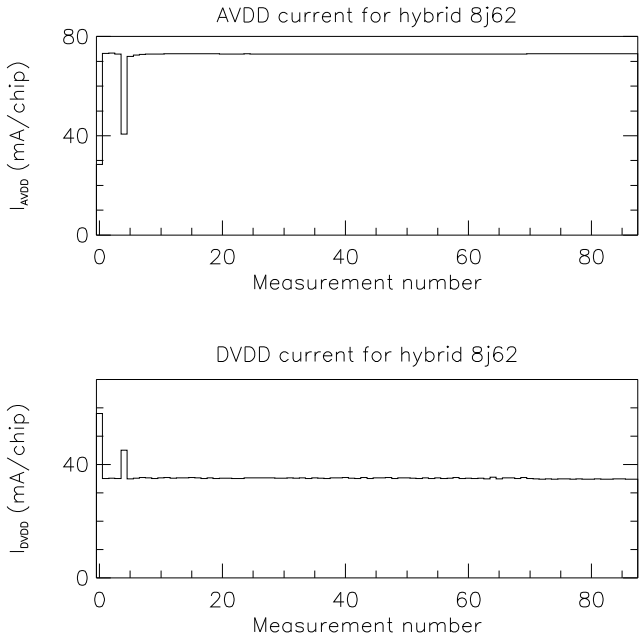
Supply Currents During Burn-in

The following plots show the supply currents per chip as a function of measurment number. Currents are measured approximately every 10 minutes:
