Hybrid 8j70 Traveler

April 28, 2000

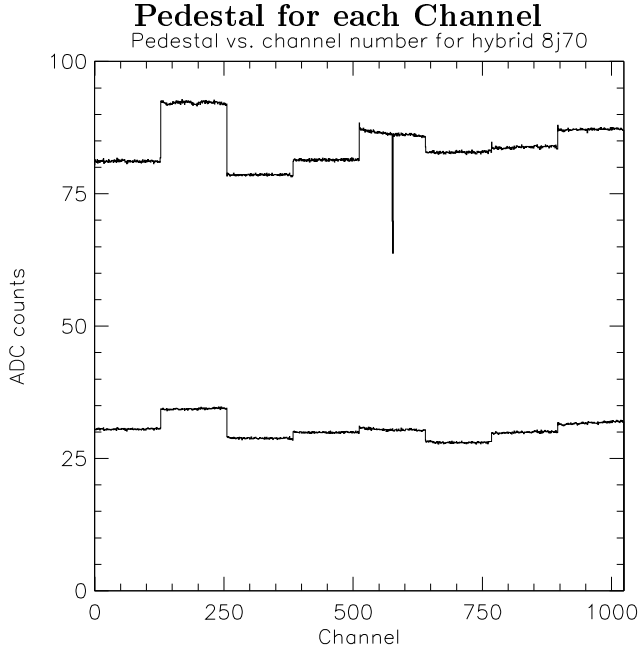
Pedestal for each Channel

The following plot shows the pedestals vs. channel number with and without charge injection:

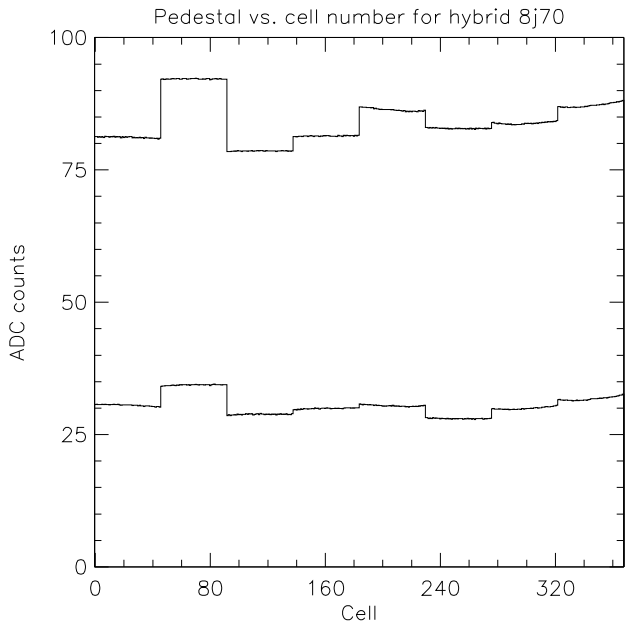
Pedestal vs. Pipeline Cell ID

The following plot shows the average pedestal vs. pipeline cell ID with and without charge injection. The x-axis is cell ID offset by 46 for each chip. Thus cell ID 5 for chip 1 is at x=5, chip 2 at x=51, chip 3 at x=97, etc.

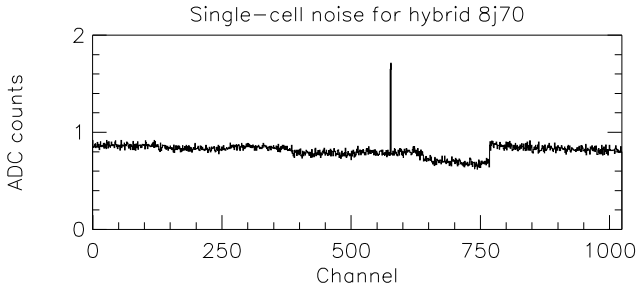
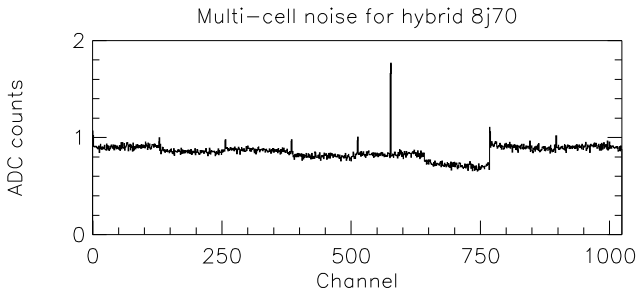
RMS Noise

The following plots show the single-cell and multi-cell RMS noise:

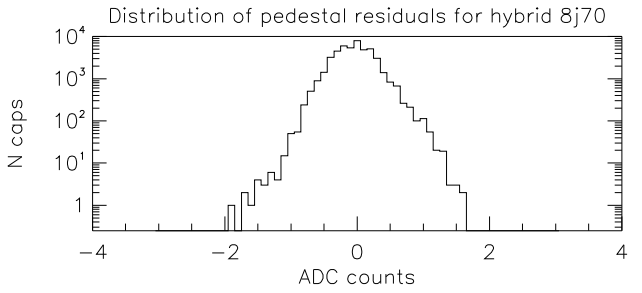
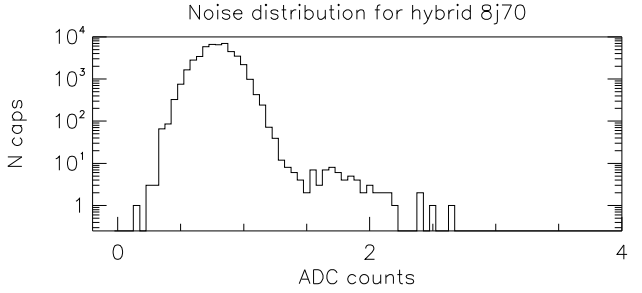
Distribution of Pedestals and Noise

The following are histograms of the pedestal of each pipeline capacitor relative to the chip average (top); and the RMS noise of each capacitor (bottom):

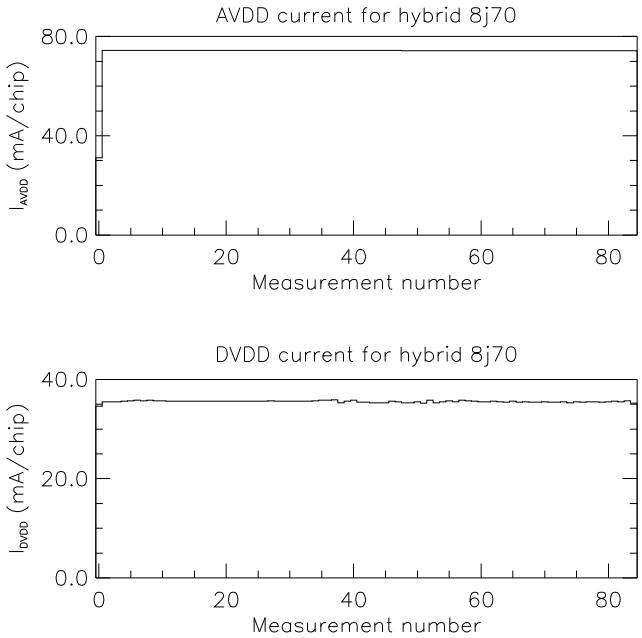
Supply Currents During Burn-in

The following plots show the supply currents per chip as a function of measurment number. Currents are measured approximately every 10 minutes:
