Hybrid 8j72 Traveler

November 15, 1999

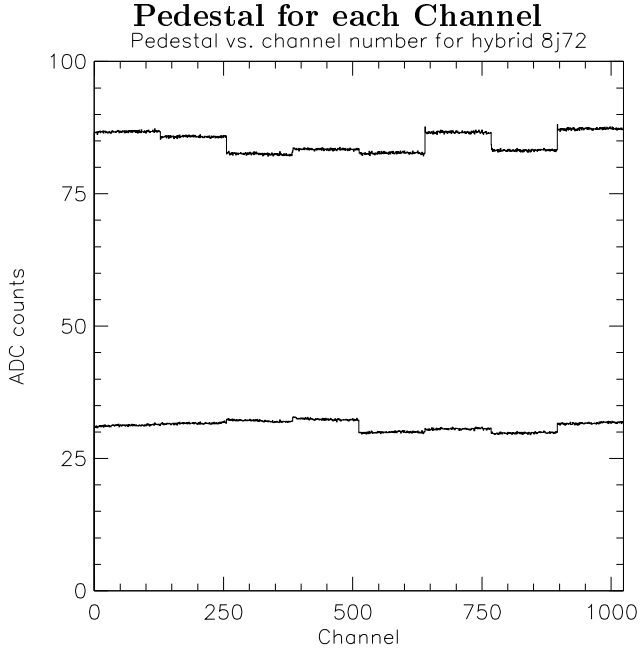
Pedestal for each Channel

The following plot shows the pedestals vs. channel number with and without charge injection:

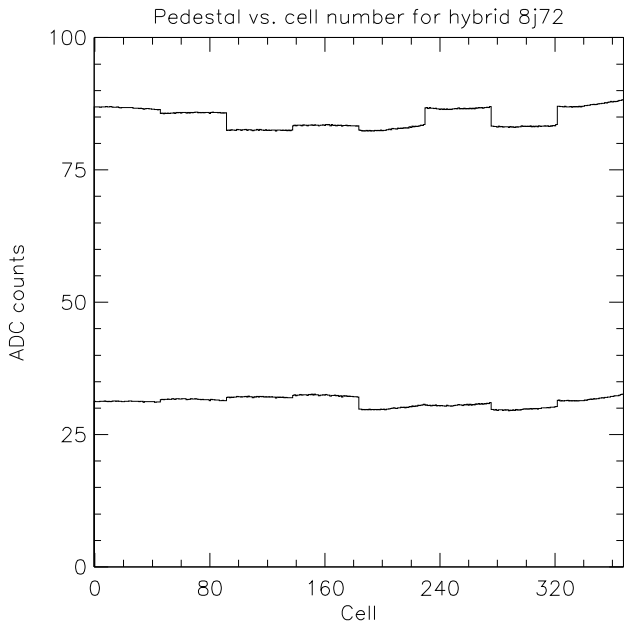
Pedestal vs. Pipeline Cell ID

The following plot shows the average pedestal vs. pipeline cell ID with and without charge injection. The x-axis is cell ID offset by 46 for each chip. Thus cell ID 5 for chip 1 is at x=5, chip 2 at x=51, chip 3 at x=97, etc.

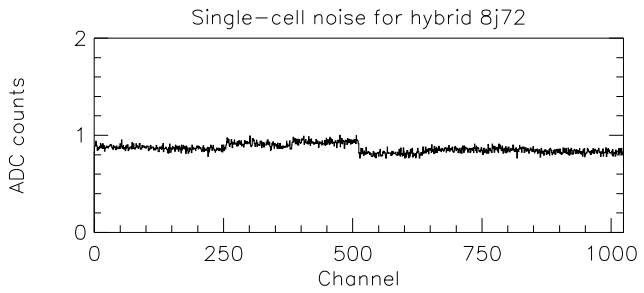
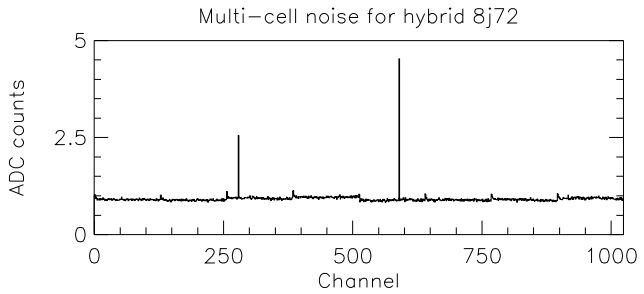
RMS Noise

The following plots show the single-cell and multi-cell RMS noise:

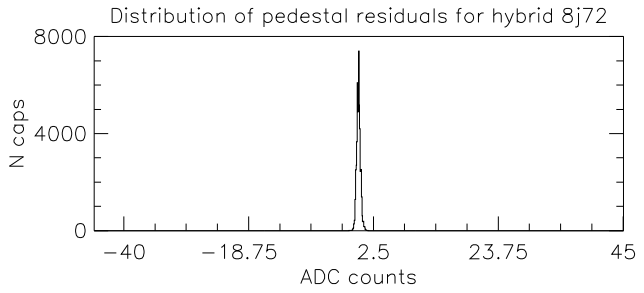
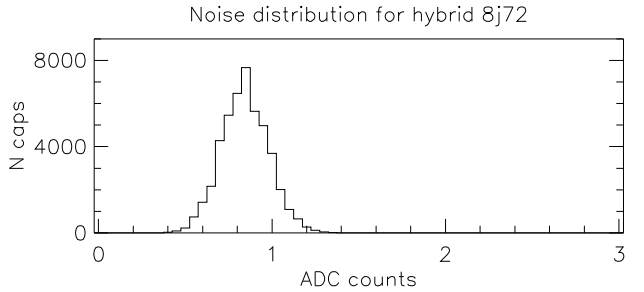
Distribution of Pedestals and Noise

The following are histograms of the pedestal of each pipeline capacitor relative to the chip average (top); and the RMS noise of each capacitor (bottom):

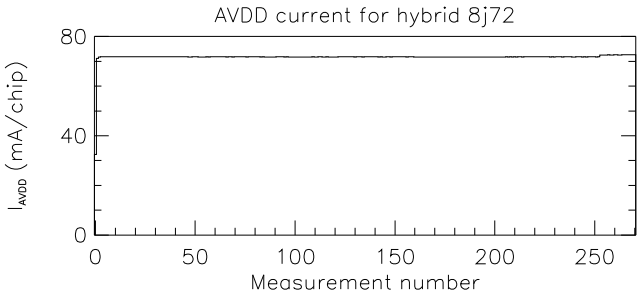
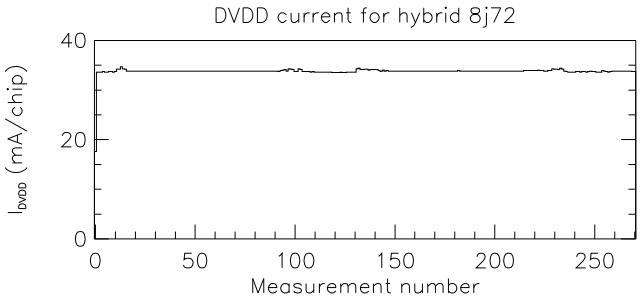
Supply Currents During Burn-in

The following plots show the supply currents per chip as a function of measurment number. Currents are measured approximately every 10 minutes:
