Hybrid 8j98 Traveler

December 17, 1999

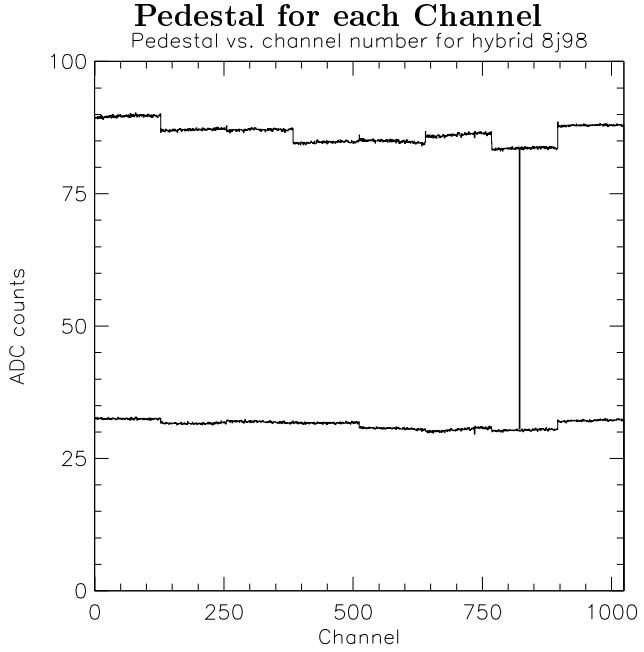
Pedestal for each Channel

The following plot shows the pedestals vs. channel number with and without charge injection:

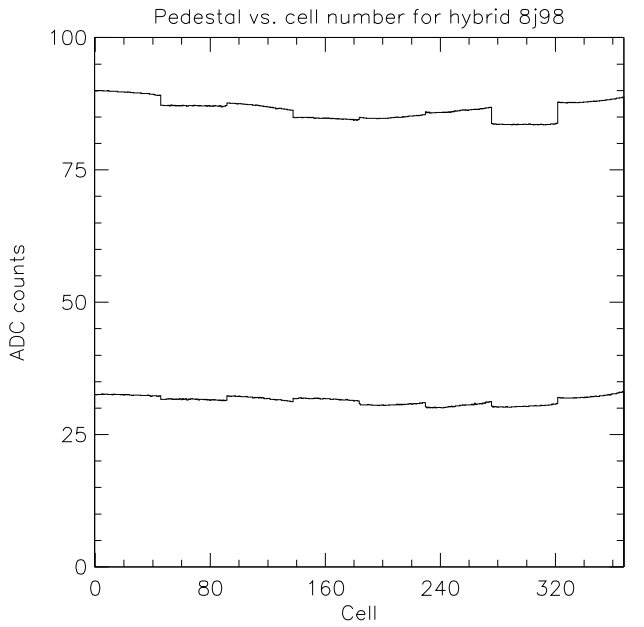
Pedestal vs. Pipeline Cell ID

The following plot shows the average pedestal vs. pipeline cell ID with and without charge injection. The x-axis is cell ID offset by 46 for each chip. Thus cell ID 5 for chip 1 is at x=5, chip 2 at x=51, chip 3 at x=97, etc.

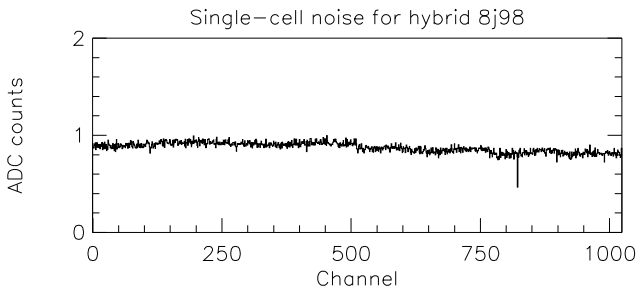
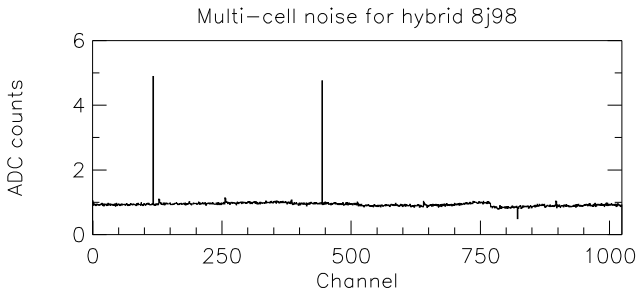
RMS Noise

The following plots show the single-cell and multi-cell RMS noise:

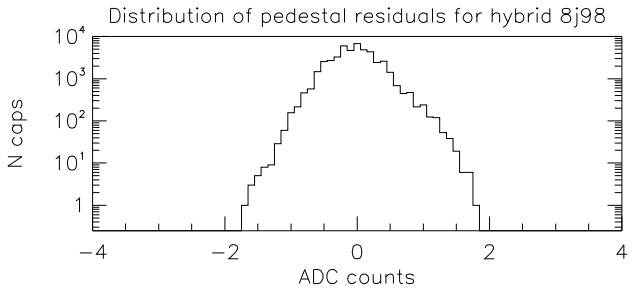
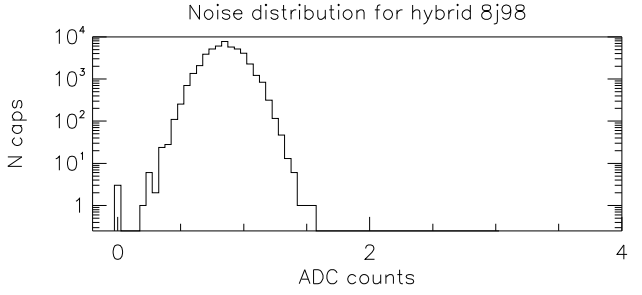
Distribution of Pedestals and Noise

The following are histograms of the pedestal of each pipeline capacitor relative to the chip average (top); and the RMS noise of each capacitor (bottom):

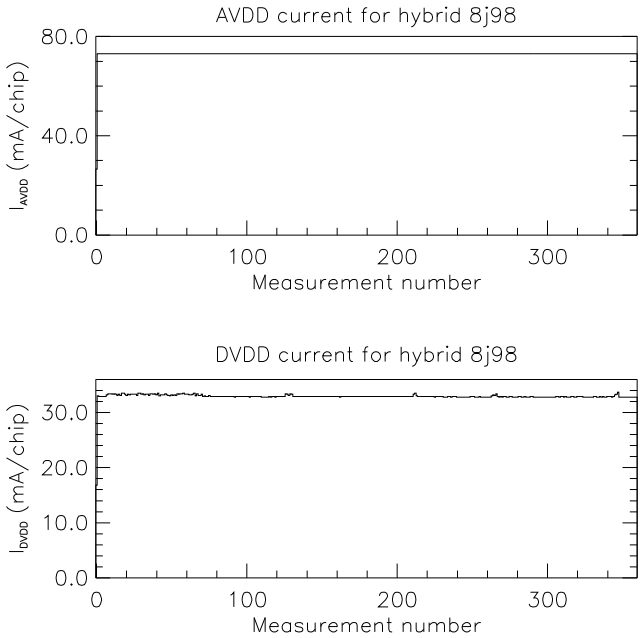
Supply Currents During Burn-in

The following plots show the supply currents per chip as a function of measurment number. Currents are measured approximately every 10 minutes:
